The Hubble Space Telescope Optical Systems Failure Report

November 1990

National Aeronautics and
Space Administration

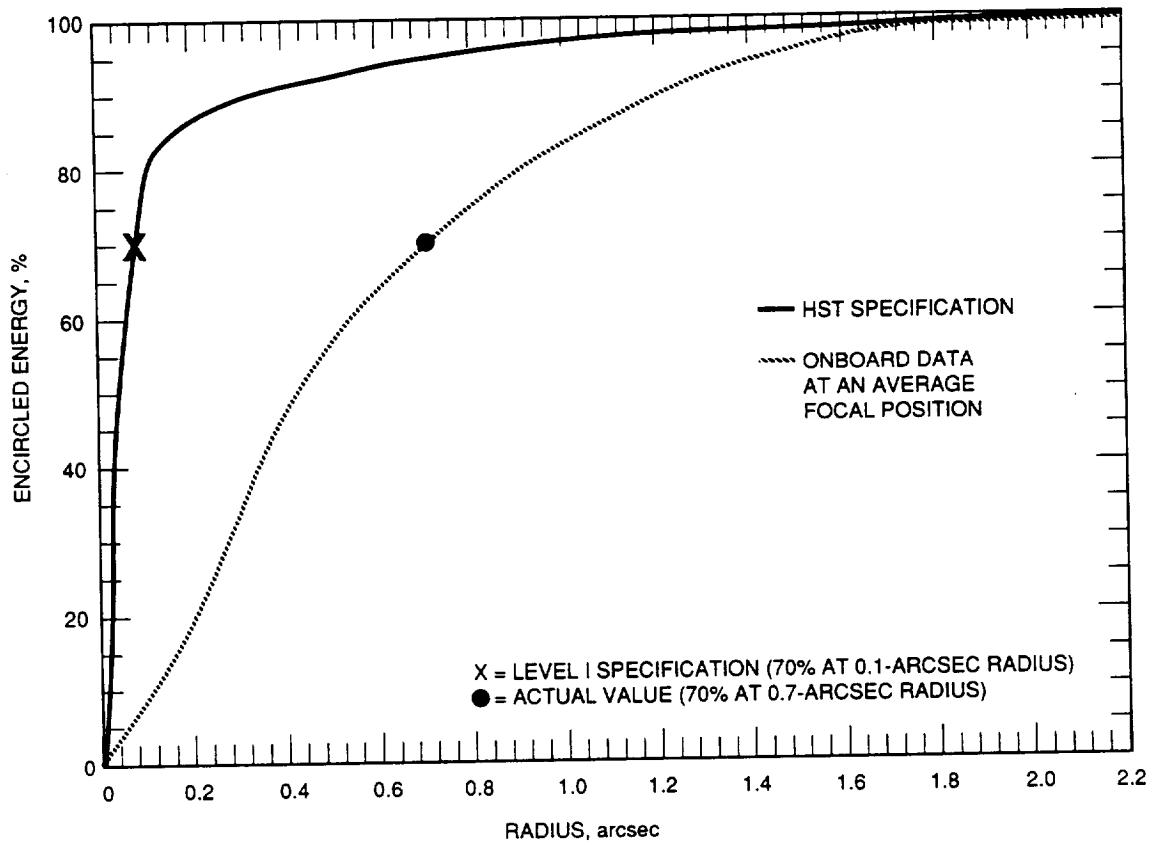
Spherical aberration distorts a point source image (e.g., a distant star) by broadening the image and surrounding it with concentric diffraction rings. This broadening effect prevents distant, closely spaced objects from being separated in the image. A tutorial on spherical and coma aberration is given in Appendix C.

Figure 5-1. Encircled energy versus arcsecond radius of image produced by the HST.

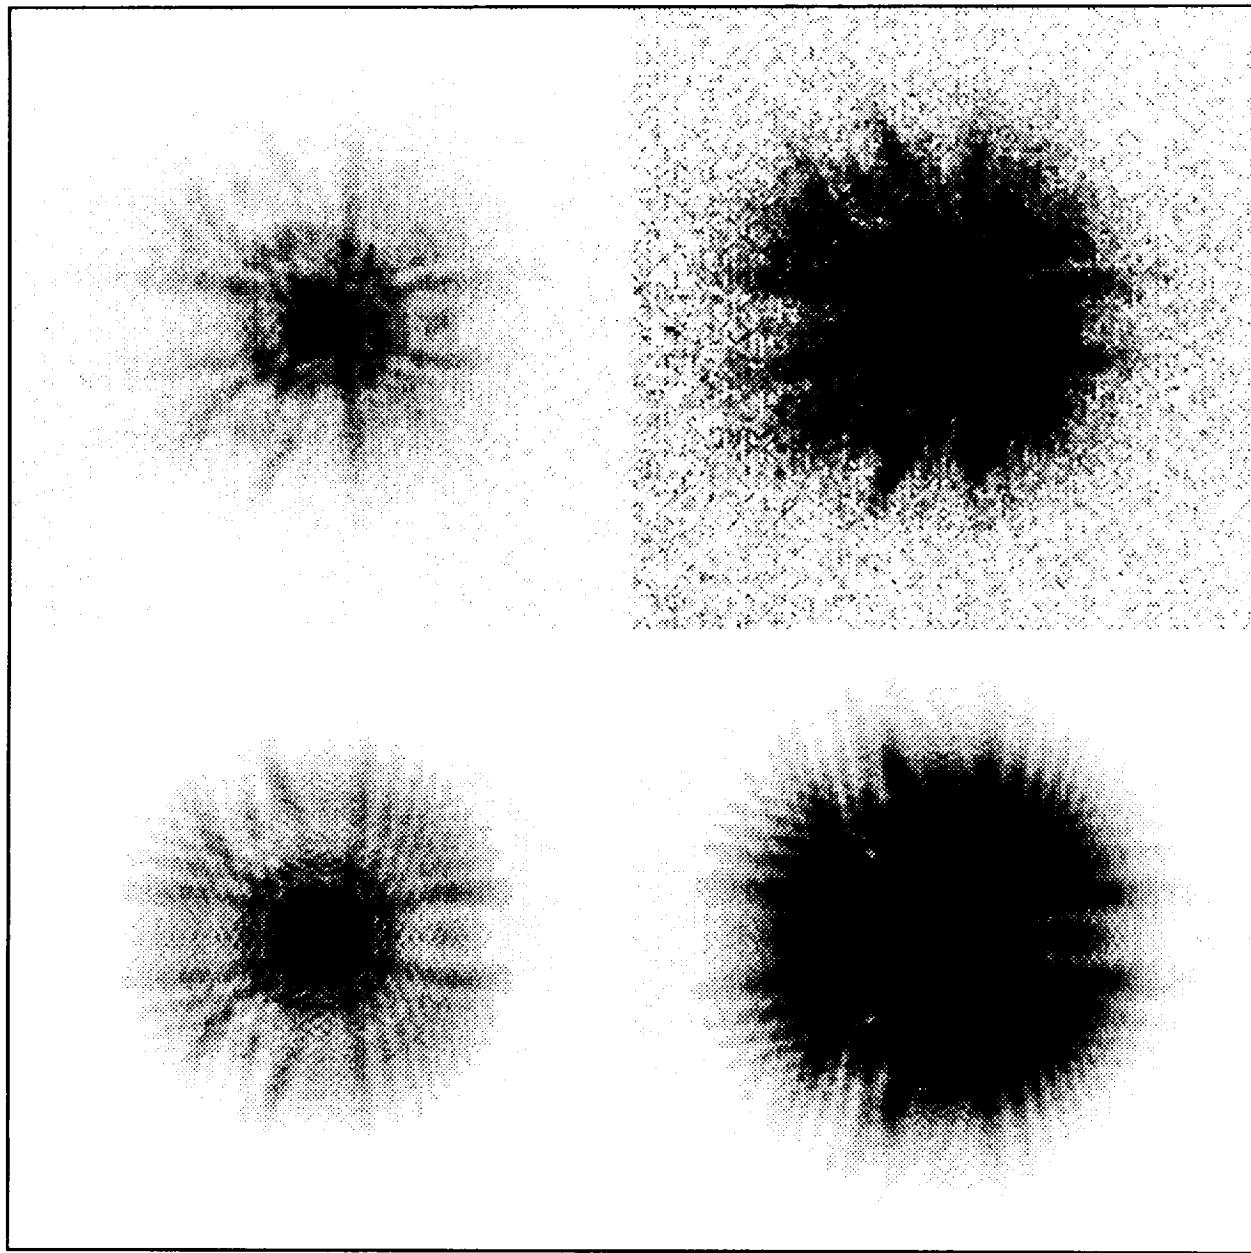
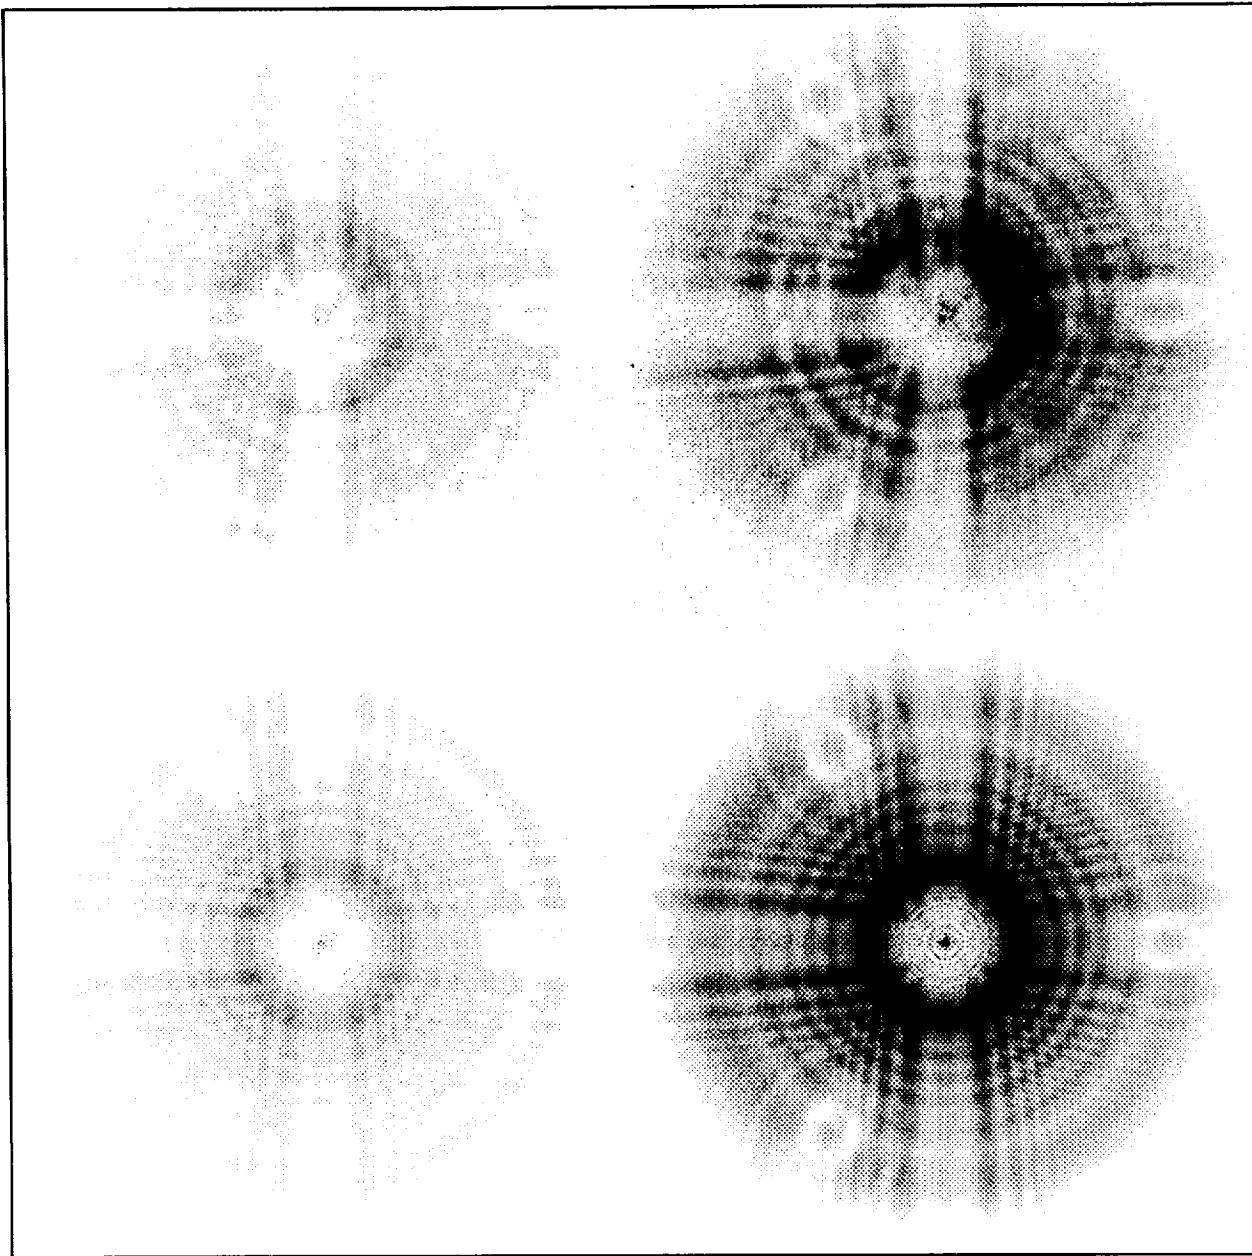
(a) Recorded image of the PC5 star taken on June 14, 1990, with a $0\text{-}\mu\text{m}$ inside focus.

Figure 6-1. Planetary Camera images versus computer simulations. The images in the top frames were taken with the Planetary Camera; those in the bottom frames are computer simulations created using an optical model with 0.5-wave rms wavefront error at 547 nm.

(b) Recorded image of the PC5 star taken on June 21, 1990, with a -300- μm inside focus.

Figure 6-1 (continued). The images in both (a) and (b) show a linear-intensity display on the left, and a logarithmic ("stretched") image display on the right. The focal position denotes the position of the secondary mirror. (Data were supplied by Dr. Jon Holtzman.)

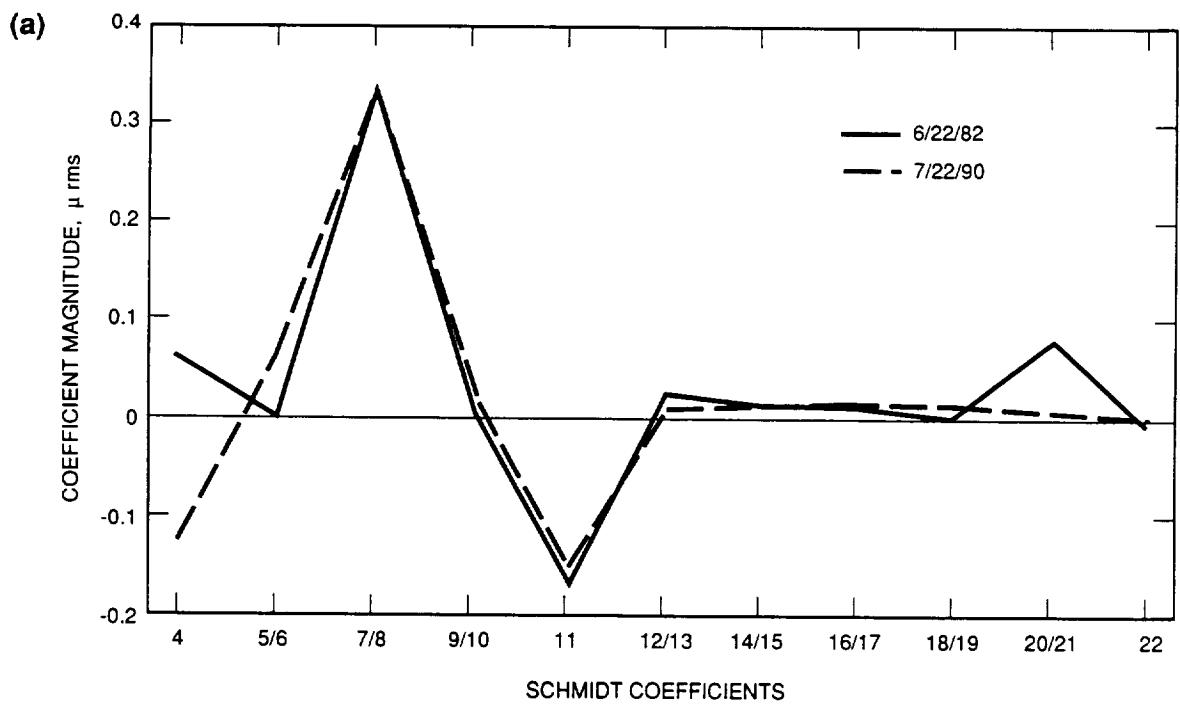
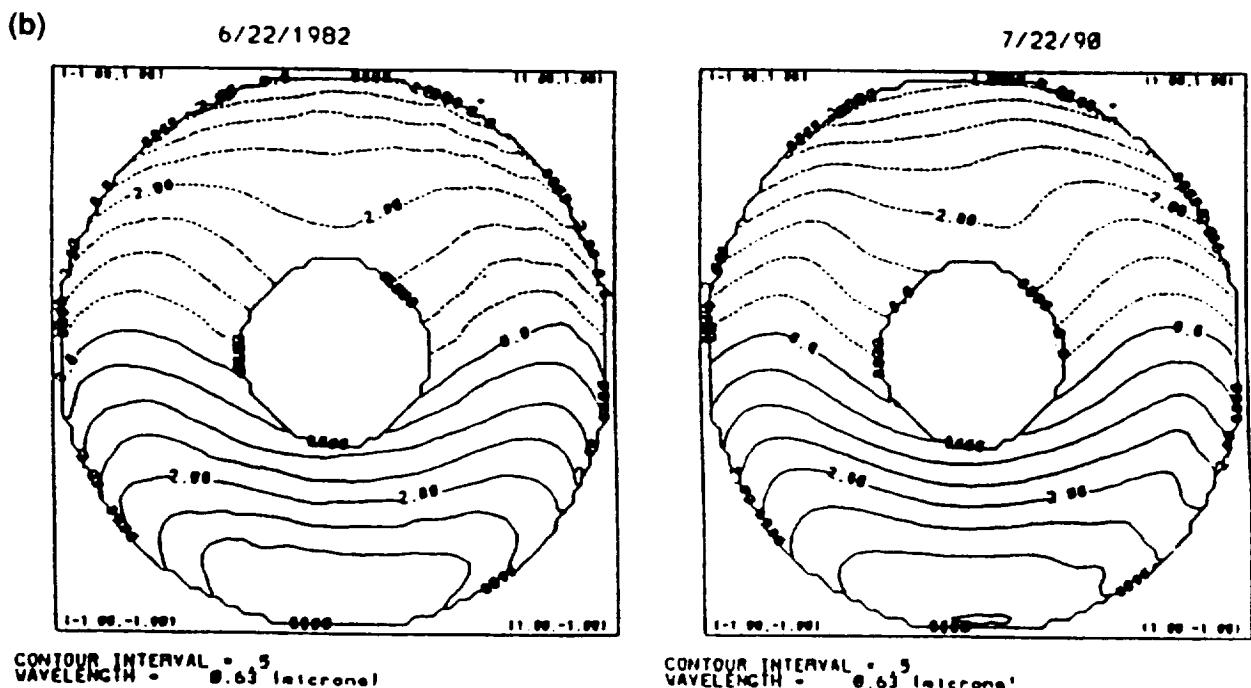
Figure 6-2. Comparison of 1982 and 1990 inverse null corrector data. (a) The coefficients which define the magnitude of various distortions to the wavefront were measured by the INC when it was inserted in front of the RNC in 1982 and in 1990. (b) The coefficient data were extracted from these plots of the interferograms.

The amount of spherical aberration introduced by the INC error is only a small amount compared to the amount of spherical aberration actually measured.

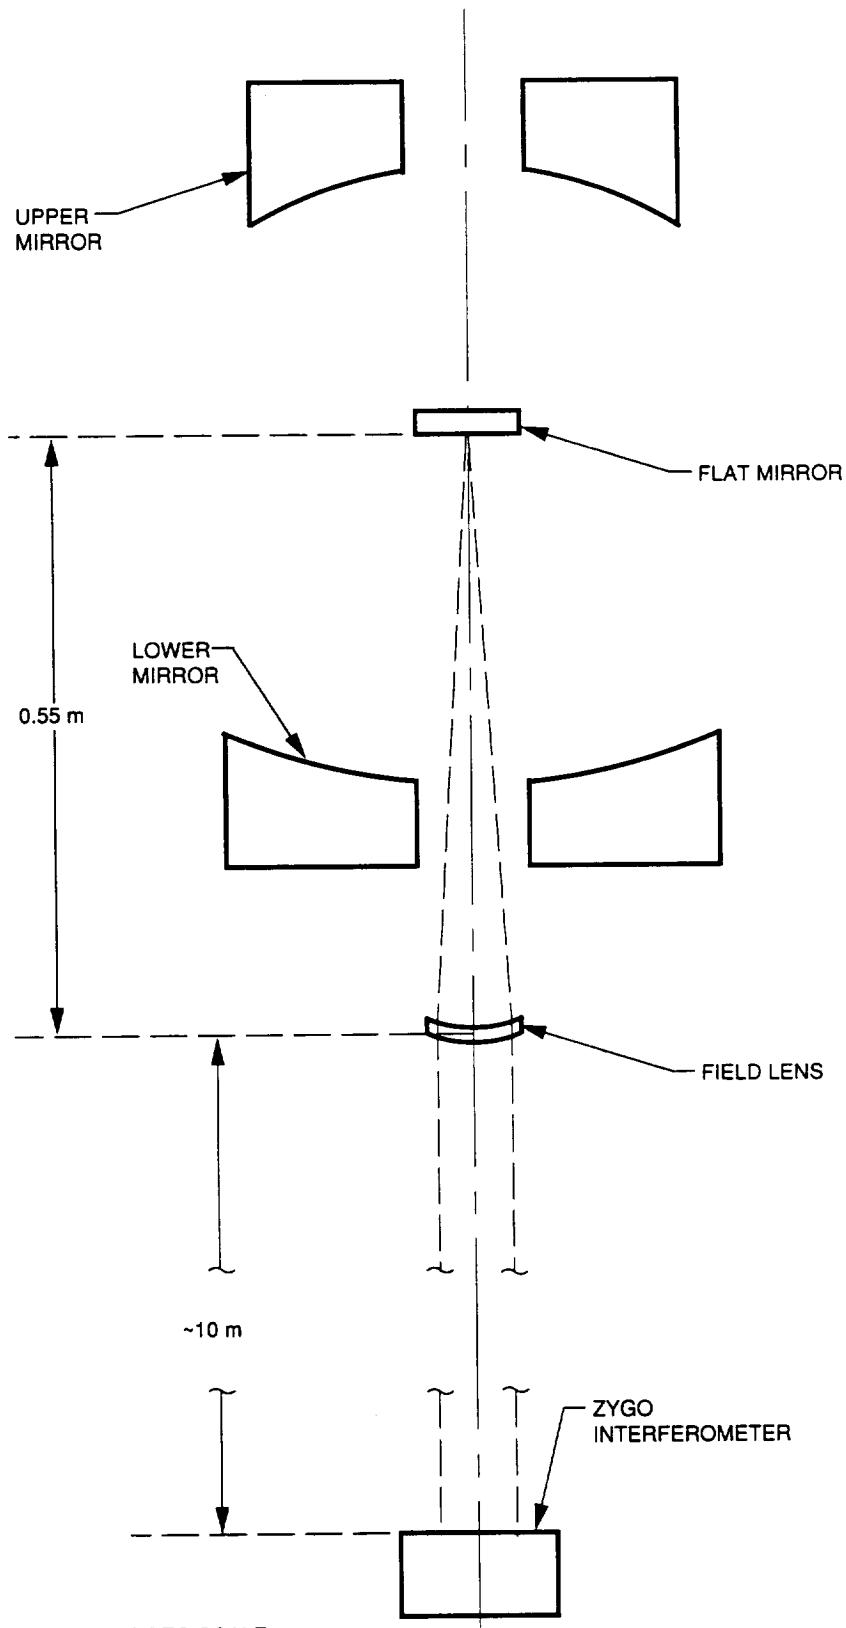
Figure 6-3. The 1990 spacing measurement between the field lens and the lower mirror of the reflective null corrector, using an optical test.

In addition to the optical test used to detect the field-lens spacing error, a direct physical measurement was made from the field lens to the vertex of the lower mirror (Figure 6-4). A lightweight spacing rod and a new vertex plug were made. The results verified the previously measured spacing error to ± 0.1 mm. More accurate measurements of the displacement error will be done at a later time, as this information is necessary for an accurate determination of a prescription for the recovery optics.

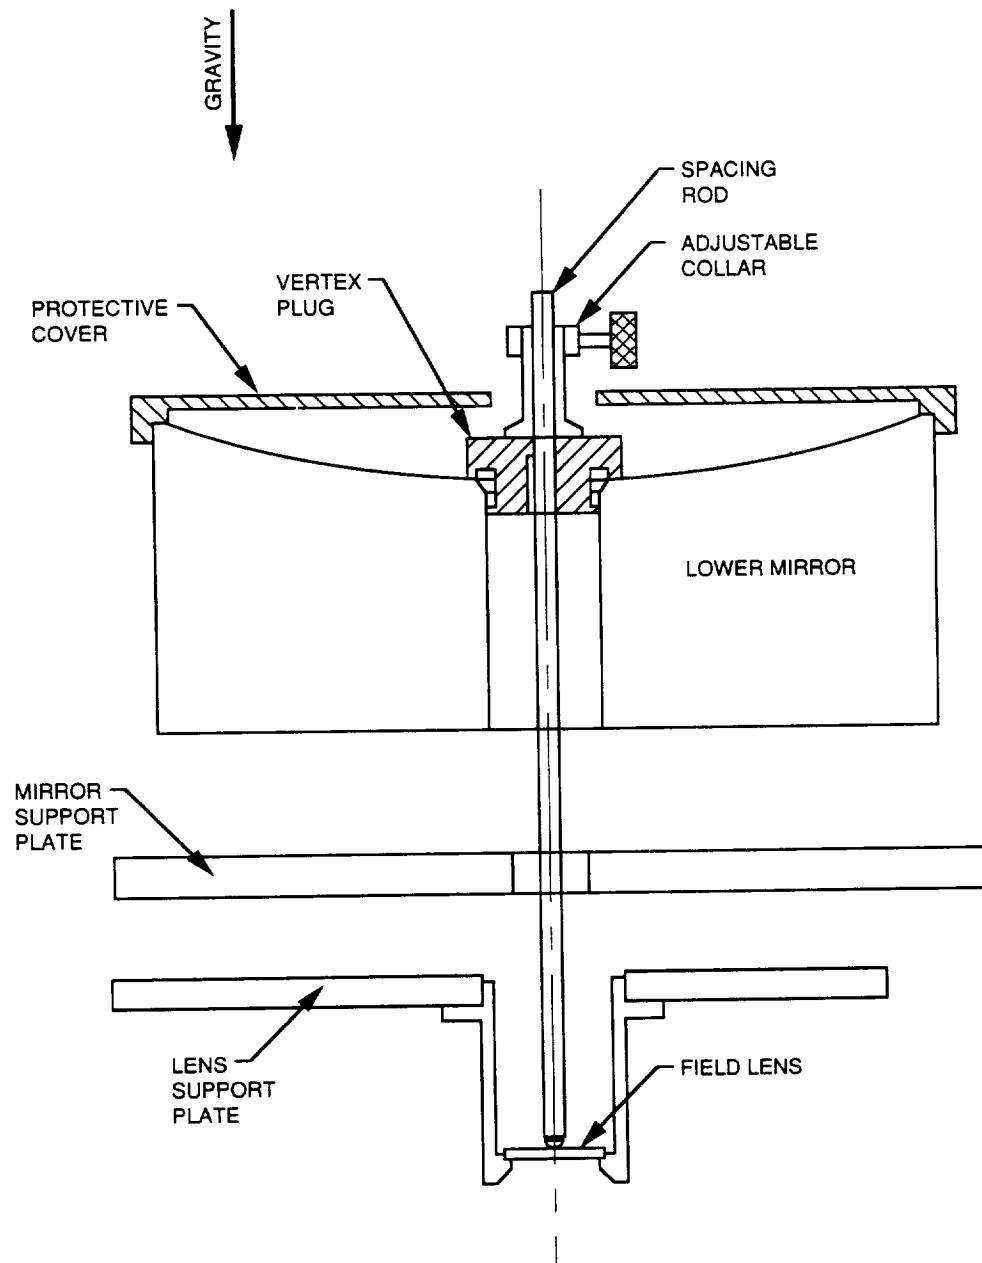
When the field lens position error (FLPE) is taken into account and applied in correcting the data taken with the RNC, it results in a mirror shape that would account for most of the error observed in the HST images. Also, the interferograms taken with the RvNC were reprocessed and corrected for the as-built data available for the RvNC. This independent set of data yields a mirror shape very close in value to the RNC/FLPE data. These data led the Board to conclude that the predominant source of error had been found and was caused by the field lens position error. (See Appendix E for the HST performance based on the as-built data.)

Figure 6-4. The 1990 spacing measurement between the lower mirror vertex and the field lens of the reflective null corrector, using a mechanical technique.

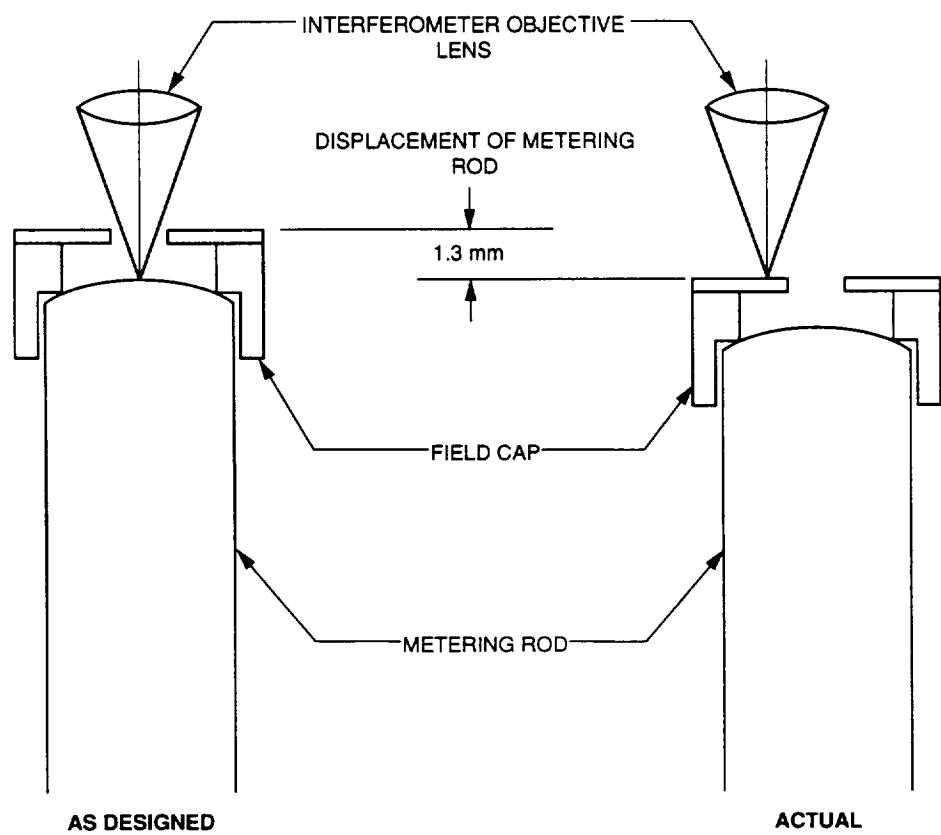
With one end of the metering rod presumably located at the center of curvature of the lower RNC mirror, the field lens was then brought up to the end of rod B, but there was no adjustment left in the screws used for this positioning. More adjustment room was made by inserting spacers between the field lens and the lower mirror mounting plate. The adjustment mechanism was found not to be staked. Staking, i.e., securing the mechanism to prevent inadvertent movement, was a specified procedure. The final location of the field lens was then set with the addition of the spacers. As a result, the field lens was about 1.3 mm too far from its correct position relative to the lower mirror.

Figure 7-4. Displacement due to the interferometer focusing on the field cap instead of the metering rod.

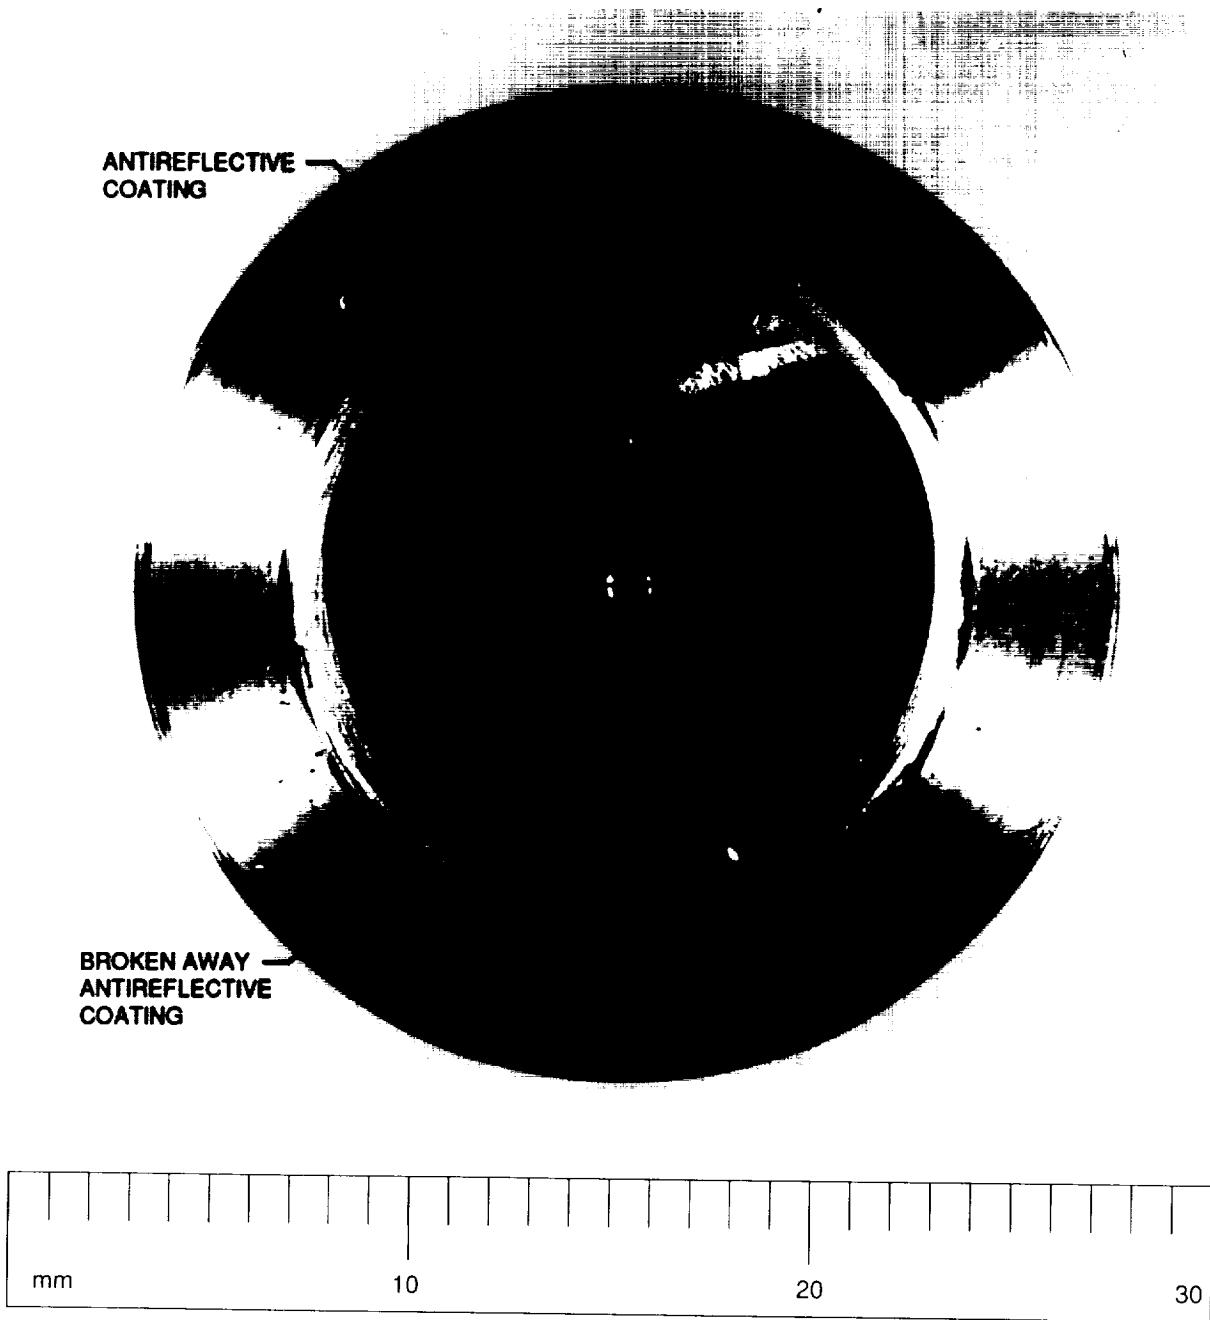
The top surface of the field cap was covered with nonreflecting material; however, some of this material had, apparently inadvertently, broken away from a small area around the field cap aperture. It appears that the operator obtained reflection from the field cap where the nonreflecting material was absent, rather than the rod end, causing the 1.3-mm misspacing. A test performed in 1990 with the equipment showed that it was quite easy, even probable, to make this error with the configuration used. Figure 7-4 indicates how the displacement error occurred by reflecting light off the field cap, rather than the rod end, as designed. Figure 7-5 is a photograph of the field cap and shows the specular region around the aperture. (In this photograph, the broken-away coating appears darker than the surrounding region.)

Figure 7-5. Top view of the field cap, showing the aperture and the area where the antireflective coating had broken away.

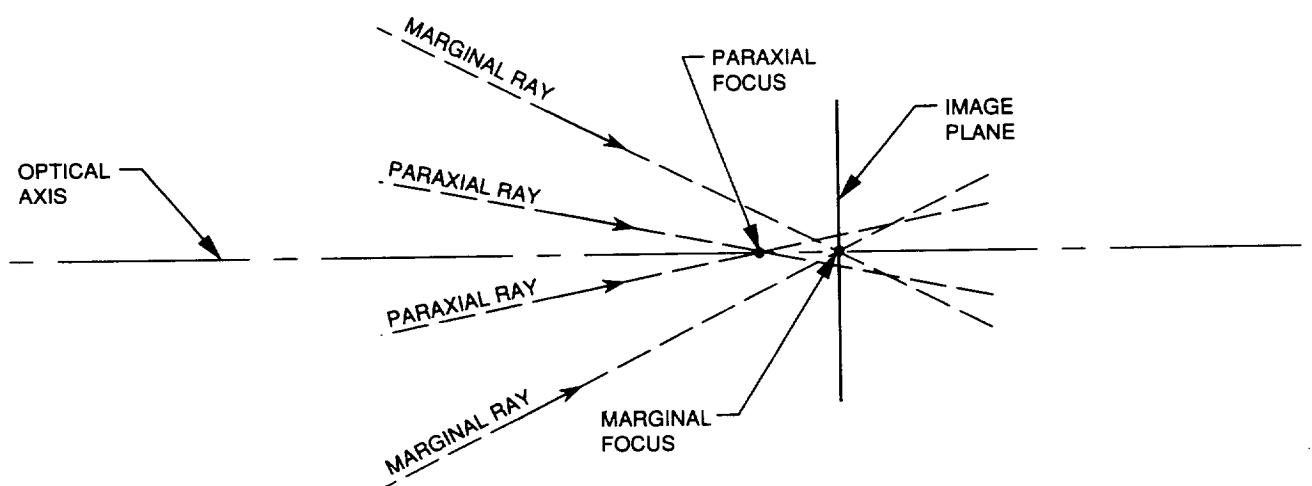
In the case of the HST, the "template" (the reflective null corrector) used to provide the reference surface for figuring the primary mirror, was not correct. In Figure C-4, we show an enlarged view of the marginal and paraxial rays as they converge in the vicinity of the vertex of the HST. Figure C-1 was used to show how the marginal focus could be superimposed on the paraxial focus by removing material. In the HST, too much material was removed from the outer edges of the primary mirror, and the marginal focus was moved to the right, past the paraxial focus. Since the marginal focus is to the right of the paraxial focus, the sign on the error is negative. Since more material than necessary was removed, the opticians call this situation "overcorrected" spherical aberration.

Figure C-4. Image-plane enlargement of the HST Ritchey-Chretien optical system. In the HST, too much material from the edges of the primary mirror was removed, and the marginal focus was moved past the paraxial focus. This is characteristic of an optical system overcorrected for spherical aberration.

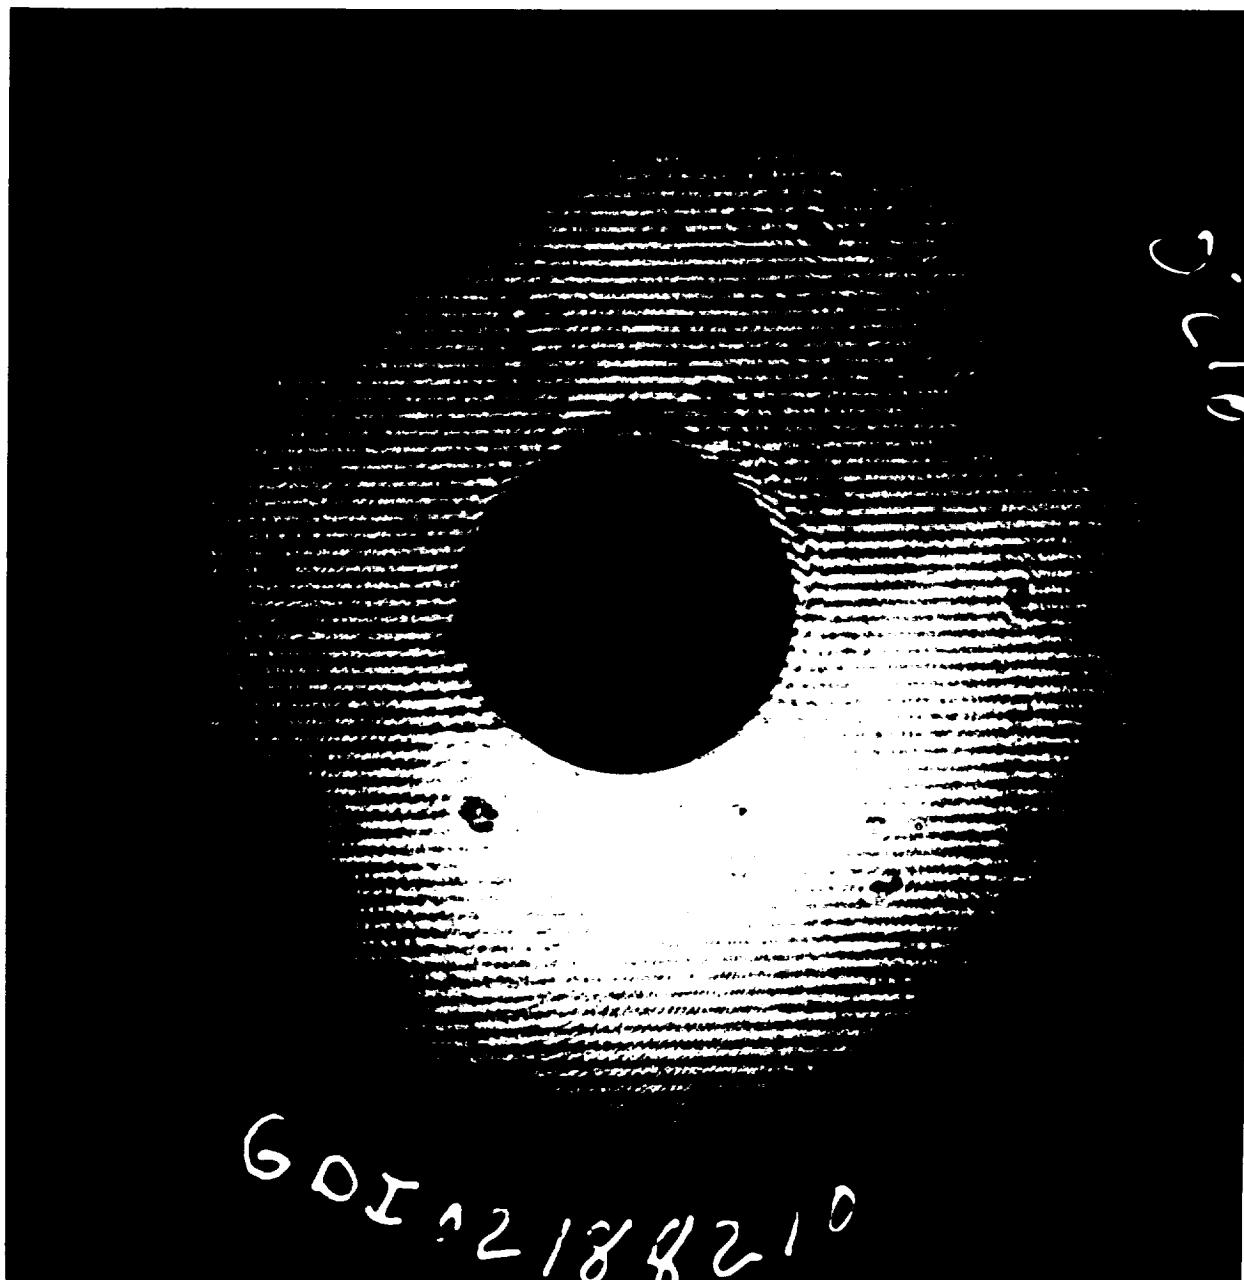
This interferogram shows three circular obscurations that cover penetration holes in the mirror surface. The obscurations were not directly part of the mirror support system, but they covered catch plates that would keep the mirror from breaking loose of the mount and damaging portions of the space shuttle orbiter, should the shuttle have had to abort the flight and return to Earth in an emergency landing. The fringe pattern also indicates the presence of local, sharp surface errors that actually fall outside of the clear aperture being used in the telescope. The semicircular marks at the periphery are fiducials used to locate the aperture in the fringe digitization process. The other defects indicated in the picture are glass chips and marks attached to components in the reflective null corrector.

Figure D-1. RNC interferogram of the primary mirror, taken in February 1982.
