**NOAA N-PRIME Mishap Investigation**  
**Final Report**

**September 13, 2004**

Report Title: NOAA N-Prime Mishap Investigation Report

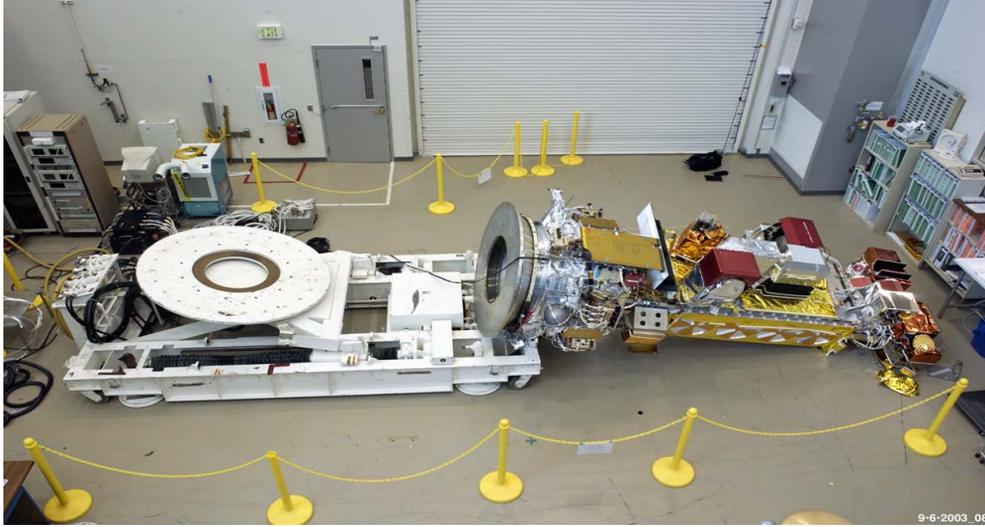
On Saturday, September 6, 2003 during an operation at Lockheed Martin Space Systems Company (LMSSC) Sunnyvale that required repositioning the Television Infrared Observational Satellites (TIROS) National Oceanic and Atmospheric Administration (NOAA) N-Prime satellite from a vertical to a horizontal position, the satellite slipped from the Turn-Over Cart (TOC) and fell to the floor (see Figure 3-1). The satellite sustained heavy damage (see Figure 3-2), although no injuries to personnel occurred. The exact extent of the hardware damage is still being assessed.

FIGURE 3-1: NOAA N-PRIME FELL OFF THE TURNOVER CART

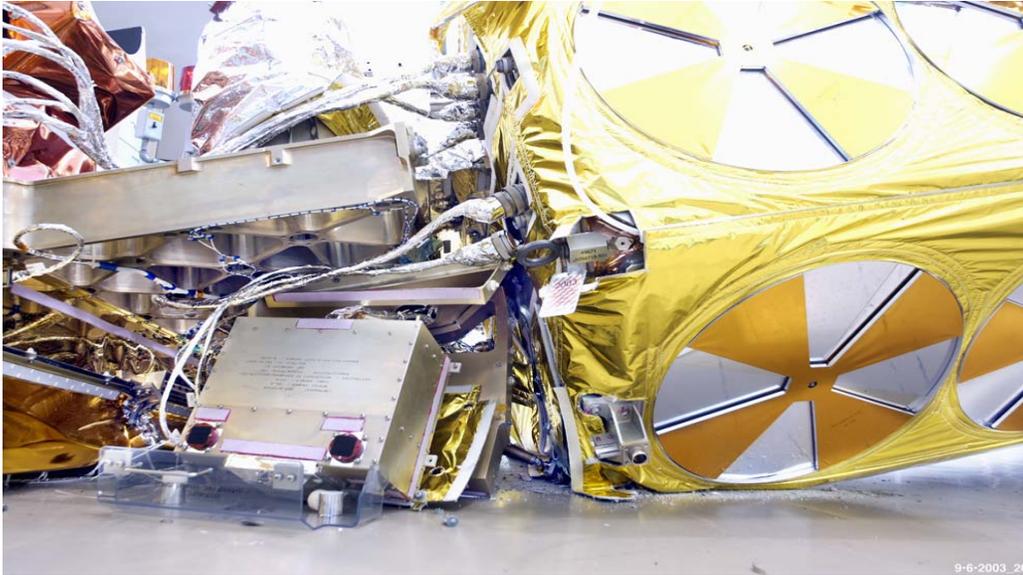
Figure 3-2: NOAA N-PRIME DAMAGES

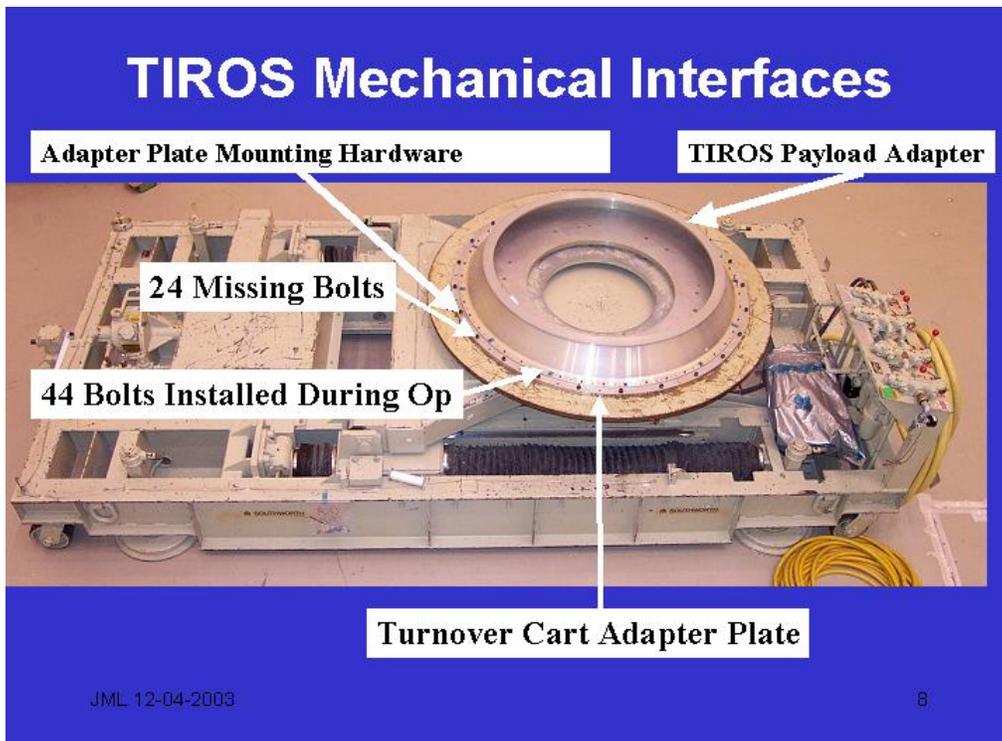
The operation scheduled for that day was to shim the Microwave Humidity Sounder (MHS) instrument by removing and replacing the instrument. This operation required the spacecraft to be rotated and tilted to the horizontal position using the TOC. The spacecraft fell to the floor as it reached 13 degrees of tilt while being rotated. The reason was clear from inspection of the hardware: *the satellite fell because the TOC adapter plate was not secured to the TOC with the required 24 bolts* (see Figure 3-3).

Figure 3-3: TURN OVER CART INTERFACES

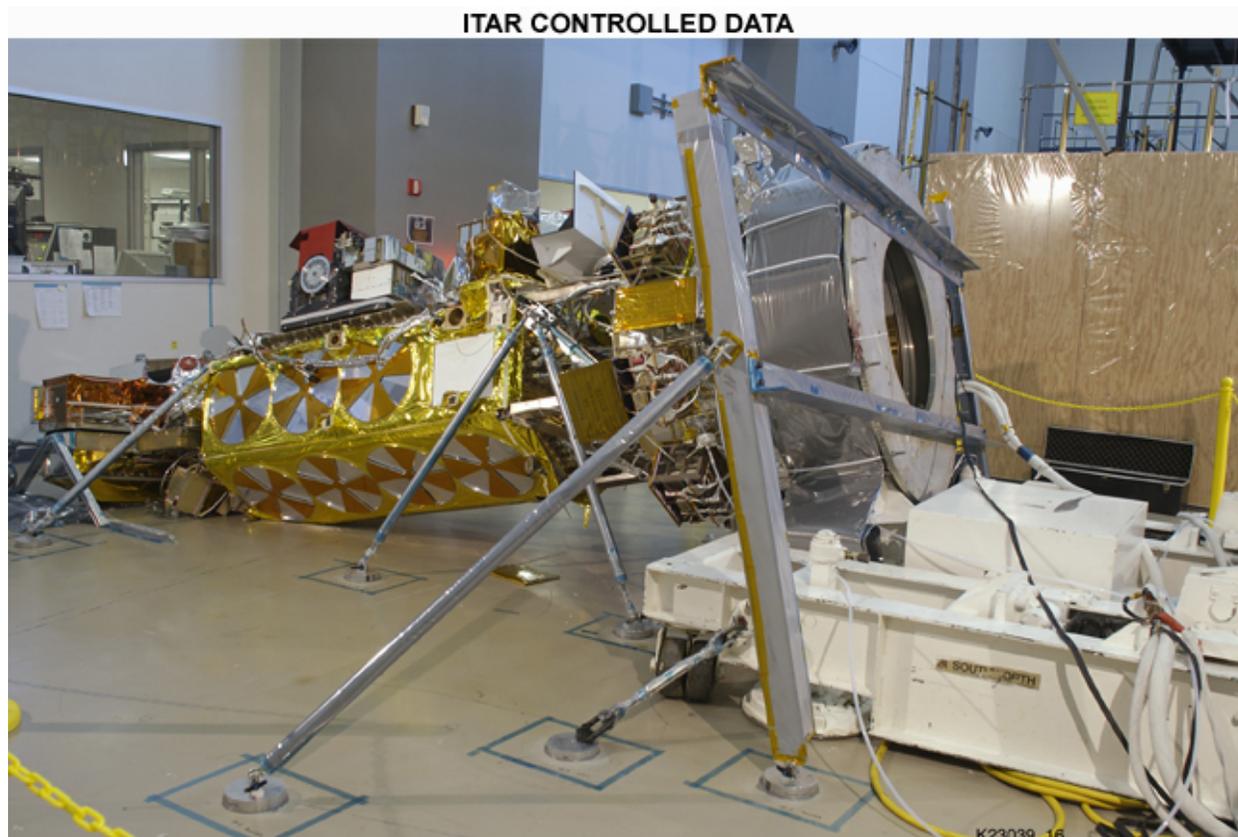
batteries were fully charged, the propulsion system was pressurized, and the separation band was tensioned. (Figure 5-1: NOAA N-PRIME Safed)

**Figure 5-1: NOAA N-PRIME Safed**

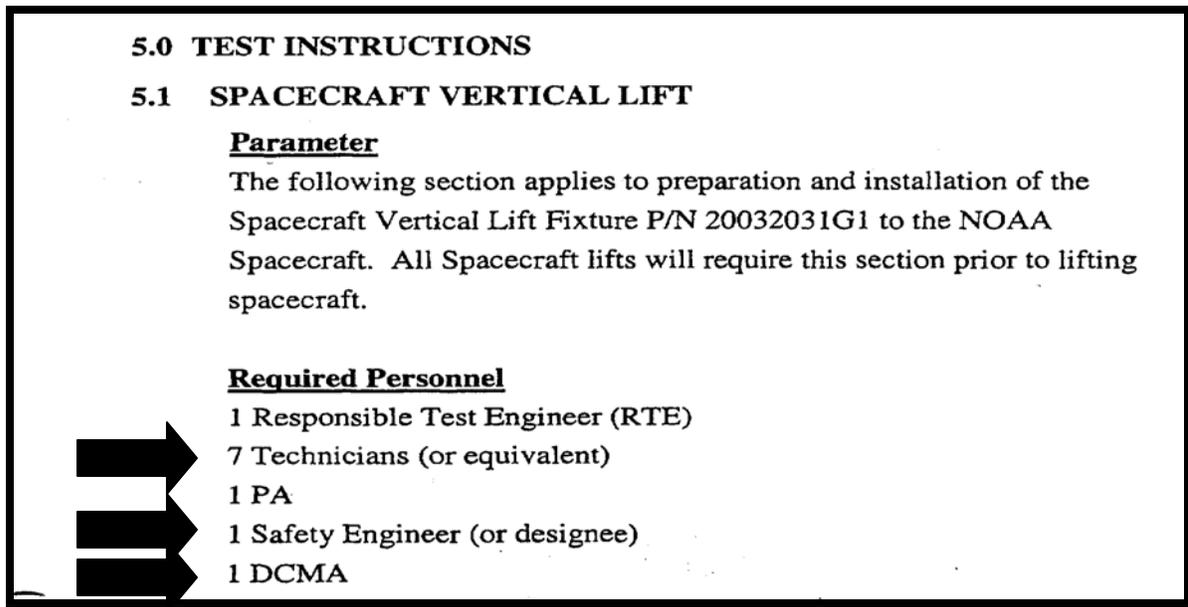
The procedure for installation of the spacecraft on the Turnover Cart (TOC) specified “1 Safety Engineer (or designee)” as part of the Required Personnel list. (Figure 5-16: TI-MH-3278200 Staffing Requirement). Safety was not notified of the operation, and a note was entered in the margin of the procedure to that effect (Figure 5-17: Procedure Record Documented That Safety Not Notified). In fact, the primary Safety Engineer was on travel supporting a launch planned by the DMSP program. An alternate Safety Engineer was specified during the primary Engineer’s absence, but no attempt was made to contact either the primary or the alternate. It was clear from this, and from previous operations indicating that Safety was notified but did not attend, that Safety was not considered an essential element of spacecraft lifting operations. This lack of involvement was not questioned by supervision. (Findings L-3, L-9, L-10, and L-13)

**Figure 5-16: TI-MH-3278200 Staffing Requirement**

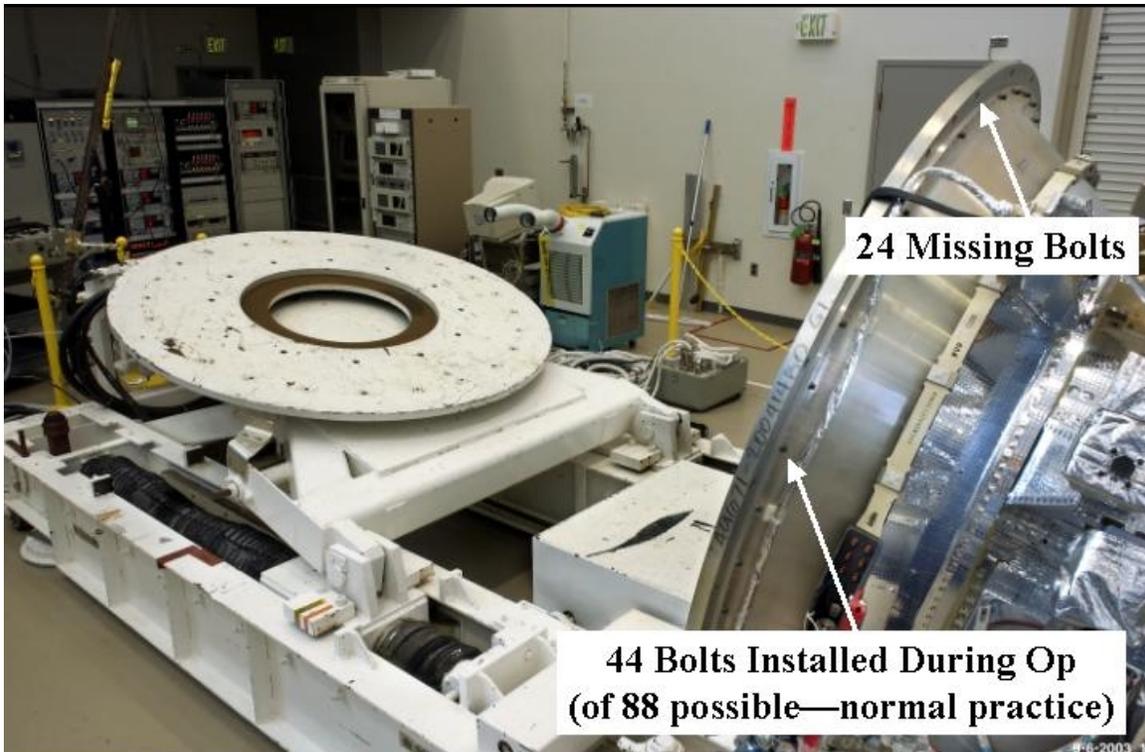
***Proximate Cause:** The NOAA N-PRIME satellite fell because the LMSSC operations team failed to follow procedures to properly configure the TOC, such that the 24 bolts that were needed to secure the TOC adapter plate to the TOC were not installed.*

Figure 5-20: TOC Showing Adapter Plate with 24 Missing Bolts

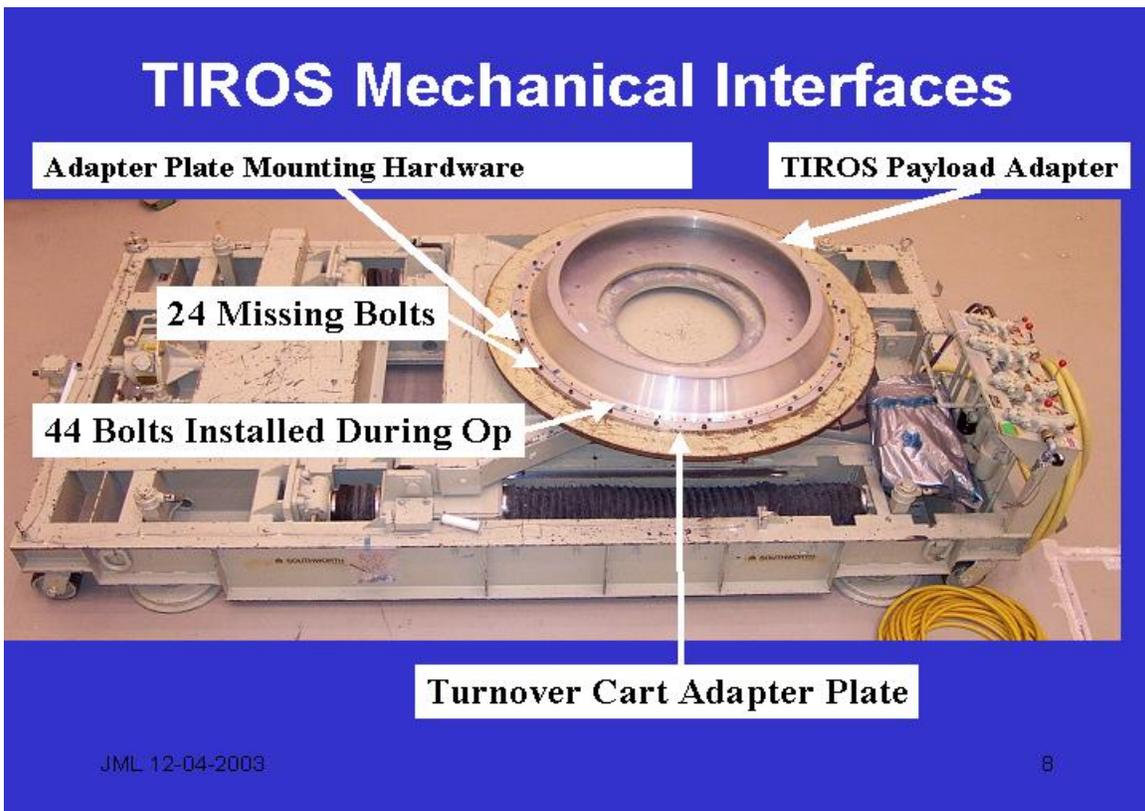
After completion of NOAA N activities using the TOC, the cart was returned to the common Ante Room. The DMSP Program decided to use this TOC for its activities because their own TOC was red-tagged with a problem. Activities to reconfigure the TOC for their own configuration began on August 27. The reconfiguration was interrupted part way through the process of the TIROS adapter ring removal, in order to install the DMSP adapter, when it was discovered the TIROS TOC was red tagged and it was determined that it would be easier for DMSP to clear the red tag on its own TOC. This change in plan left the TIROS adapter ring sitting on the TIROS TOC with its 24 attachment bolts removed. (These are the 24 bolts in question.) No red tag nor any other indication was added to the TIROS TOC to indicate the incomplete configuration; the TIROS TOC remained red-tagged due to a floor jack problem. (Figure 5-20: TOC showing Adapter Plate with 24 Missing Bolts; Figure 5-21: DMSP TOC Configuration with TIROS Adapter Plate; and Figure 5-22: TOC Diagram side view) None of this was communicated to the TIROS folks, nor was it required by the LM Command Media because the over-riding philosophy was that each user was required to verify or ensure the GSE configuration was appropriate for its own specific use each time it was used.

**Figure 5-21: DMSP TOC Configuration (with TIROS Adapter Plate in Position)**
