COMET NUCLEUS TOUR CONTOUR

MISHAP INVESTIGATION BOARD REPORT MAY 31, 2003

National Aeronautics and Space Administration

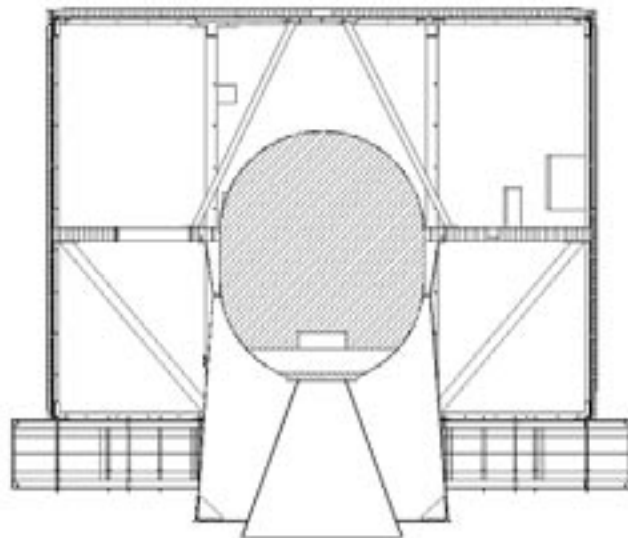
Figure 3. CONTOUR SRM configuration.

The CONTOUR Board concludes that the probable proximate cause for loss of the CONTOUR spacecraft was overheating of the forward-end of the spacecraft due to base heating from the SRM exhaust plume. The CONTOUR SRM nozzle was embedded within the spacecraft to a greater degree than is typical (Fig. 3), and the resultant near-field effect of exhaust plume heating was not adequately accounted for in the design. Overheating may have caused substantial material weakening and structural degradation, which could have led to catastrophic dynamic instability. The deficiencies in the design process are discussed further in sections 5 and 6 of this report.

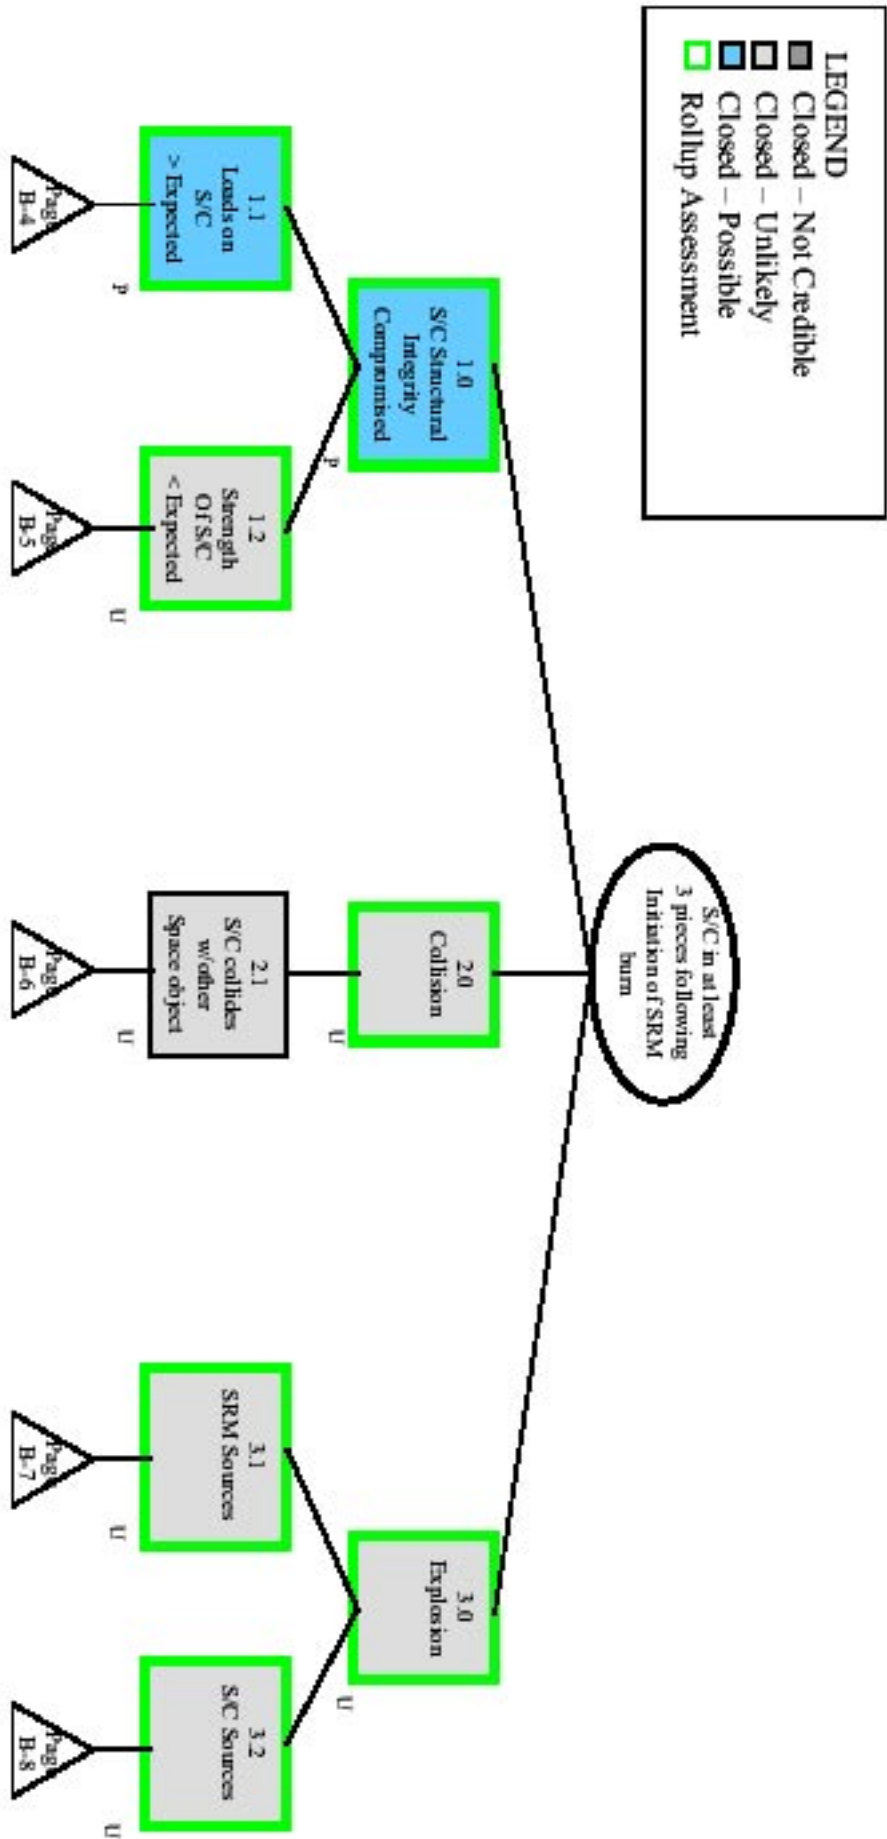
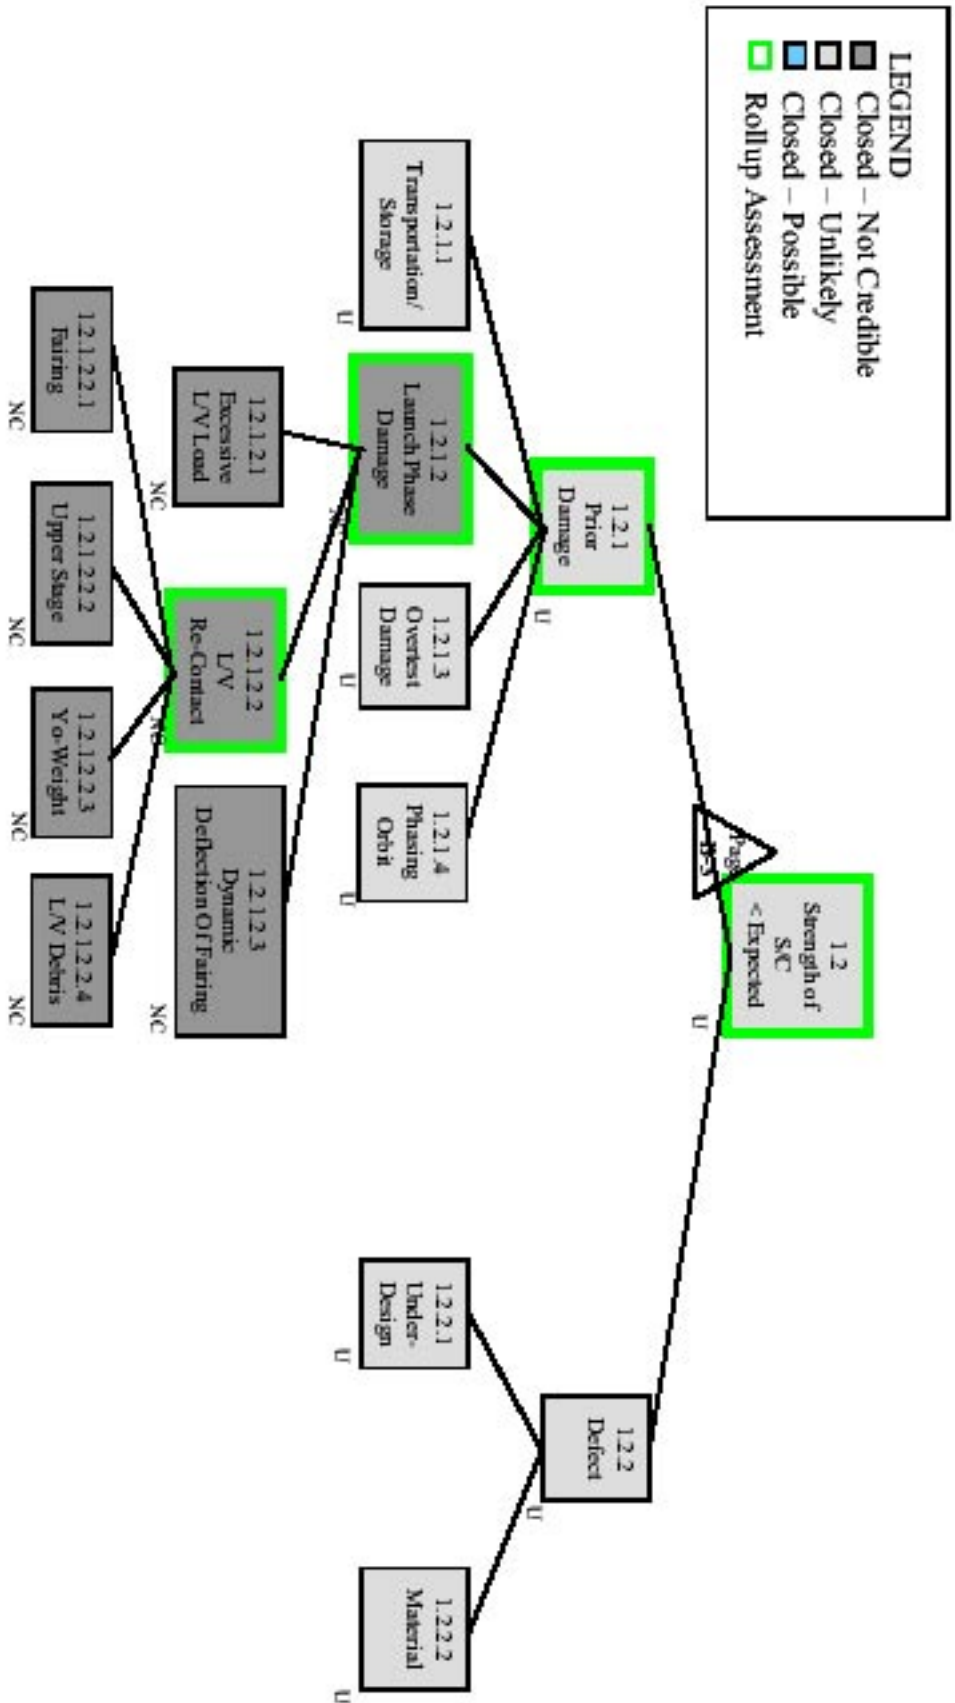
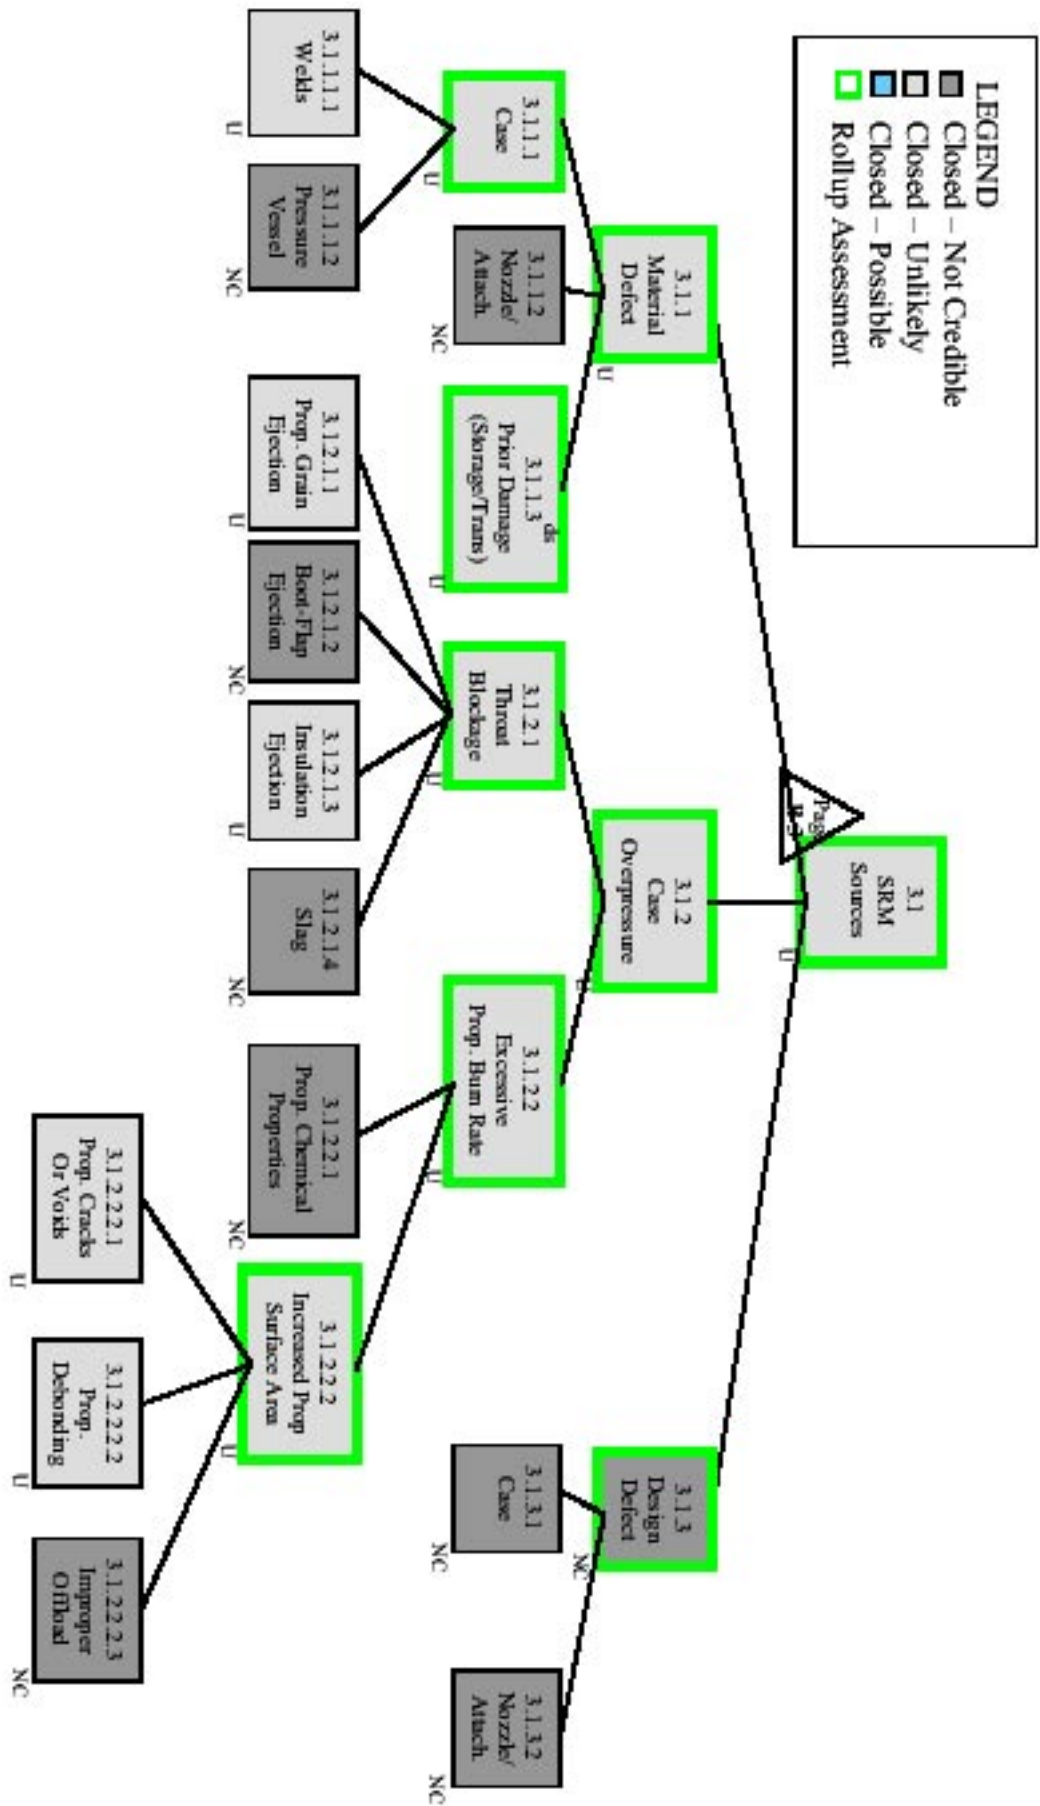
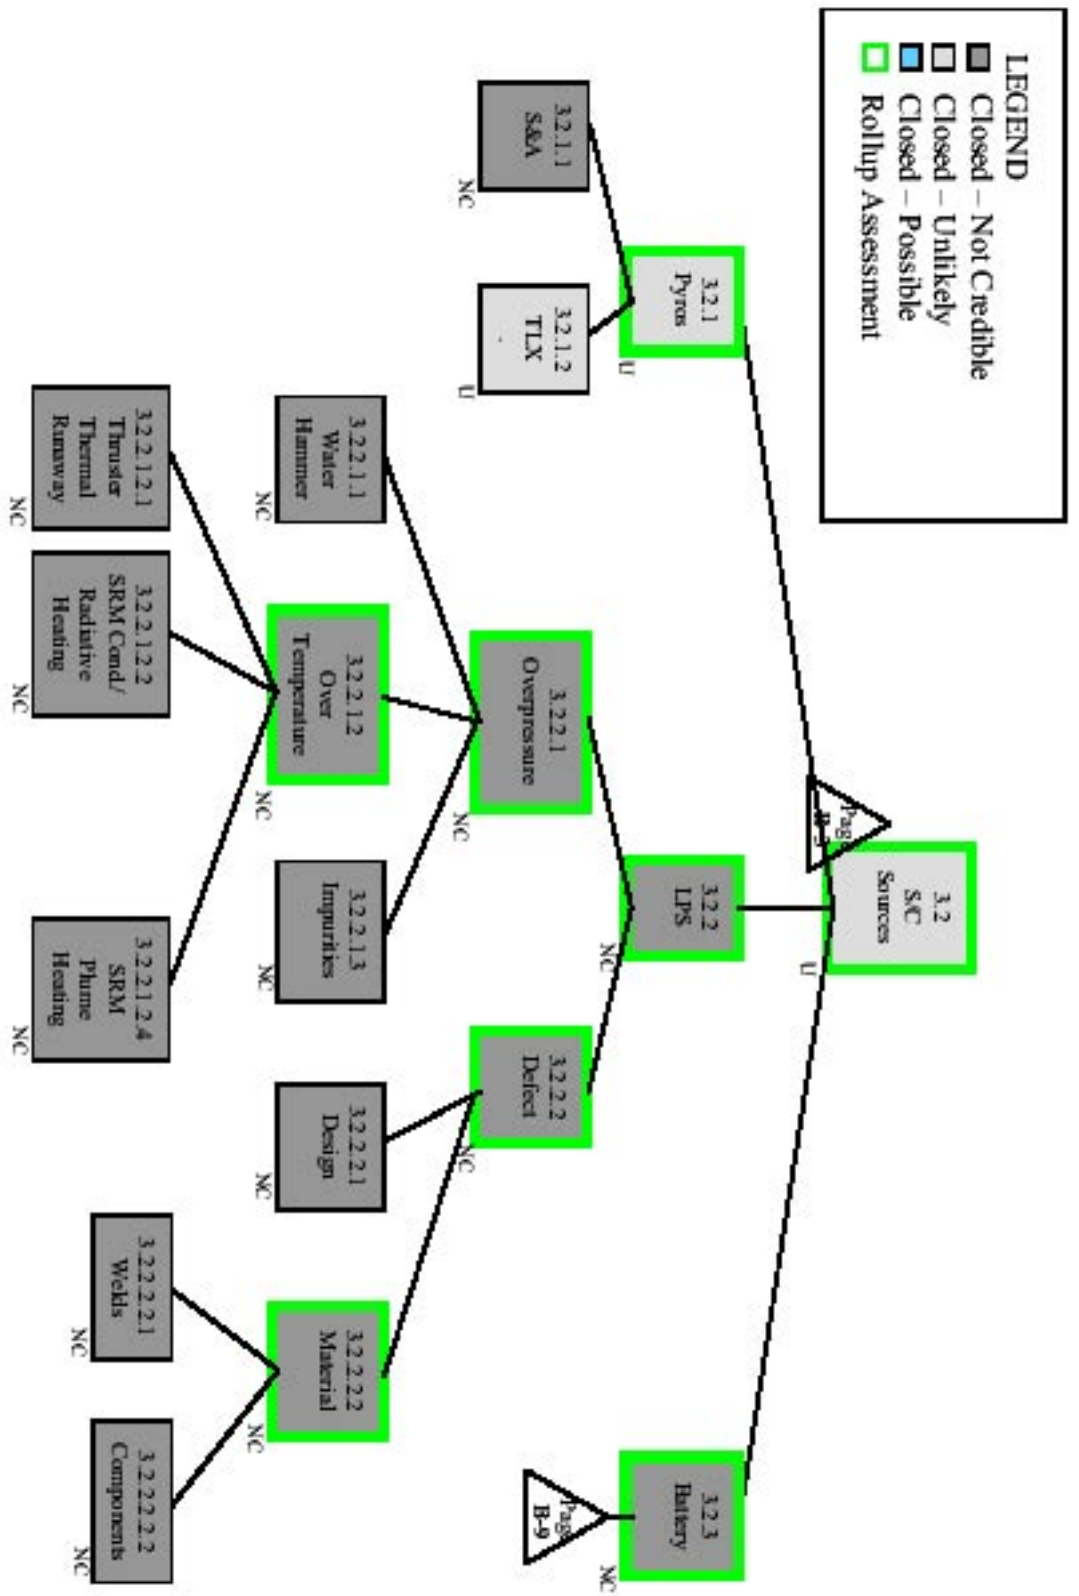
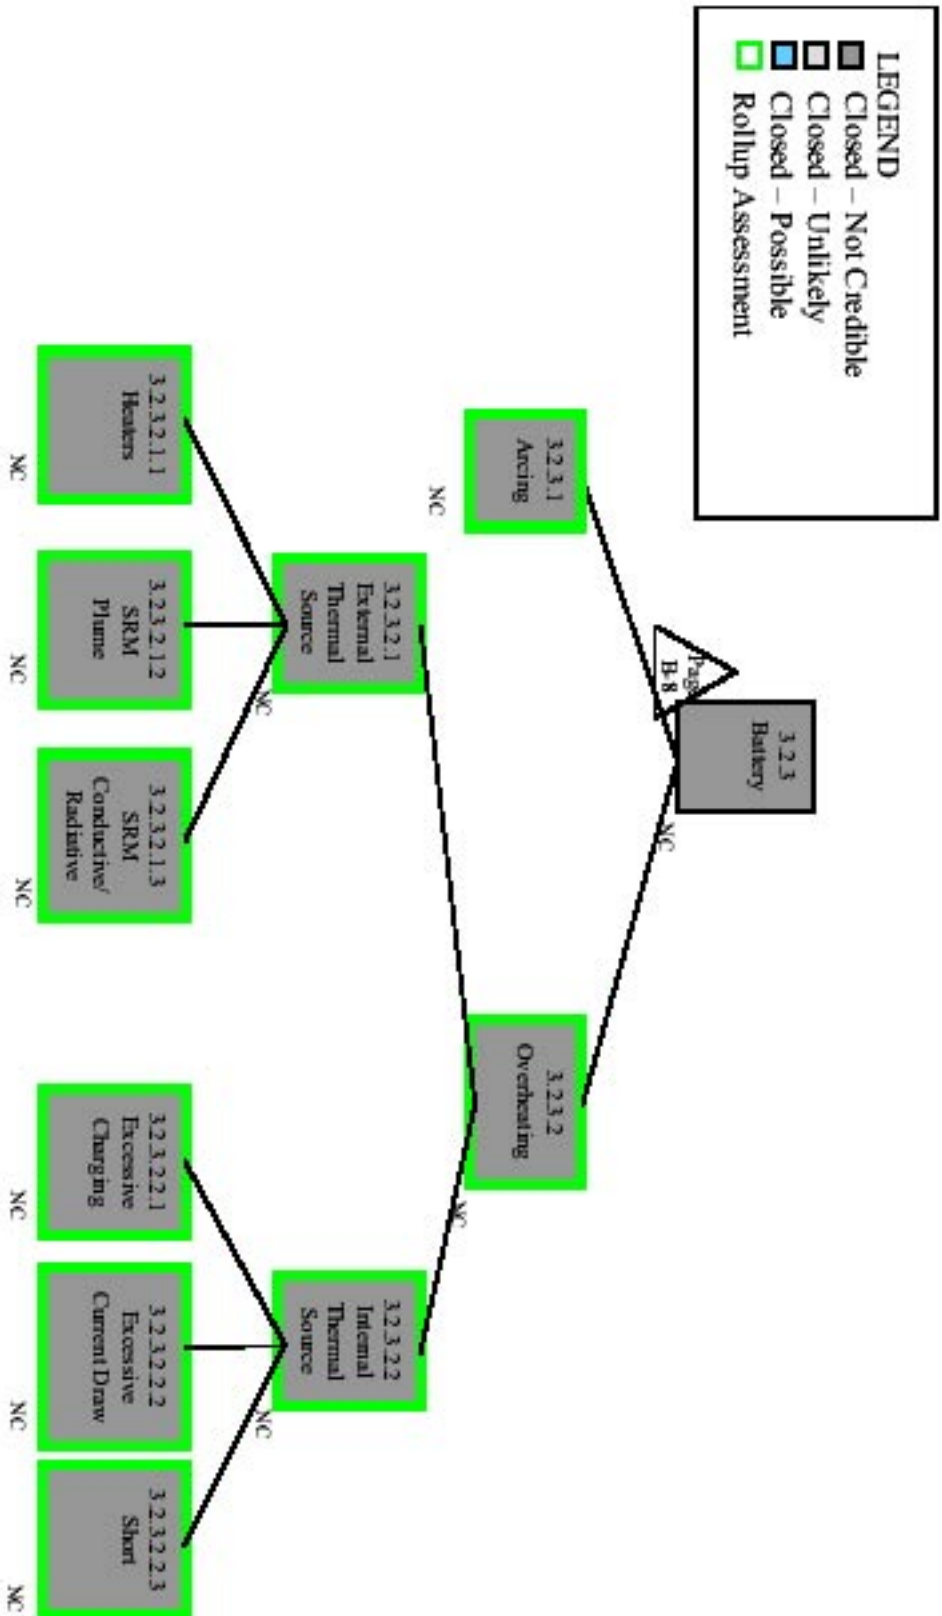
Figure B-1. CONTOUR fault tree diagram.

Following the initial information gathering meetings, the Board used Fault Tree Analysis to identify and analyze a broad range of possible failure scenarios, and to provide a systematic process to track possible causes to closure. Leads and sub-teams were assigned to the various fault tree branches/items based on areas of expertise. The leads documented and tracked the analysis and information gathering necessary to disposition each identified fault tree event. The CONTOUR MIB Fault Tree diagram is provided in Appendix B, the Fault Tree narrative is in Appendix C, and Fault Tree Closeout Records are in Appendix D.
