**LEWIS SPACECRAFT MISSION FAILURE
INVESTIGATION BOARD**

FINAL REPORT

12 February 1998

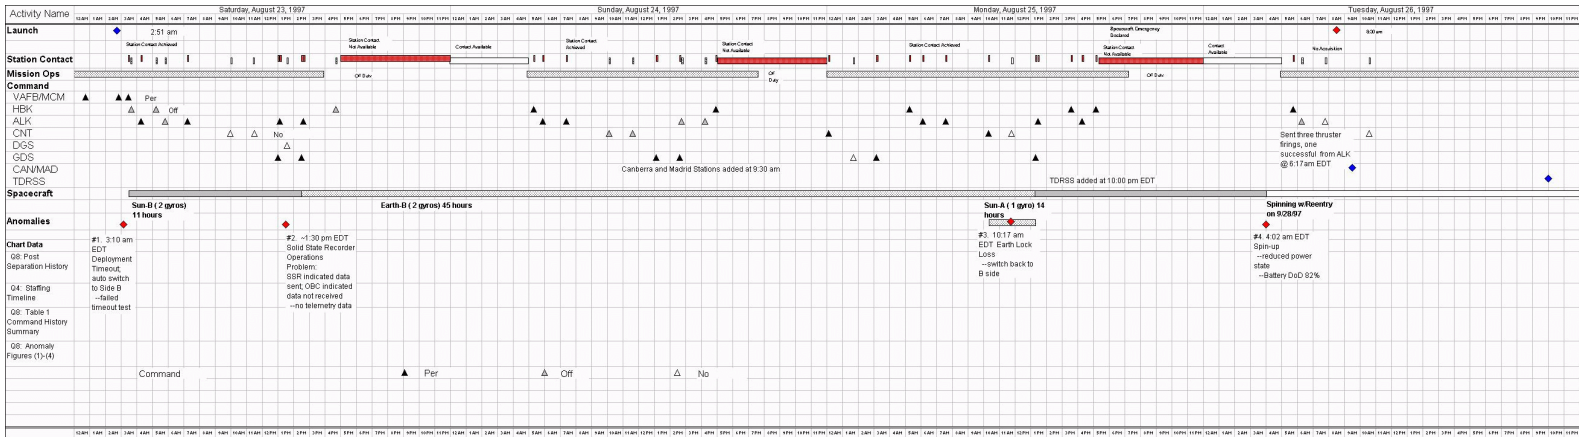
Fourth Anomaly: Spin about the Principal Axis. The fourth and final (catastrophic) anomaly occurred approximately four hours after the seven-hour ground station planned unavailability period. The anomaly manifested itself as a spacecraft flat spin (a spin about its principal axis) that pointed the solar arrays edge-on to the sun. The start of the flat spin was in a period when the ground stations were available but the operations crew had not yet returned to work and therefore went initially unnoticed. By the time of the discovery of the anomaly, the battery was in a deep depth of discharge (approximately 72%). Subsequent analyses of the situation concluded that excessive thruster firings, caused by the spacecraft autonomous attempts to control in the intermediate axis mode, were sensed by the spacecraft processor which then disabled the A-side thrusters and had switched control from A-side processor to B-side processor. Excessive thruster firings on the B-side then caused the B-side thrusters to also be disabled by the processor, leaving the spacecraft uncontrolled. The single two-axis gyro was saturated, and the spacecraft was then in free drift that resulted in rotation about the principal axis, off pointing the solar array from the Sun.

At the next and final contact pass (in this low earth orbit the ground station contact times are on the order of about five minutes each), the depth of battery discharge was 82%. In preparing for this pass, the operations crew working under extreme time pressure developed what was hoped to be a recovery plan. At the start of the contact pass the B-side thrusters were enabled by ground command, and three, one-second thruster pulses were commanded in an attempt to arrest the spacecraft rotation rate. As it turns out only the first of the three commands was executed by the dying spacecraft because the operations crew had addressed the second and third commands incorrectly. The spacecraft went out of ground station contact and was subsequently never reacquired.

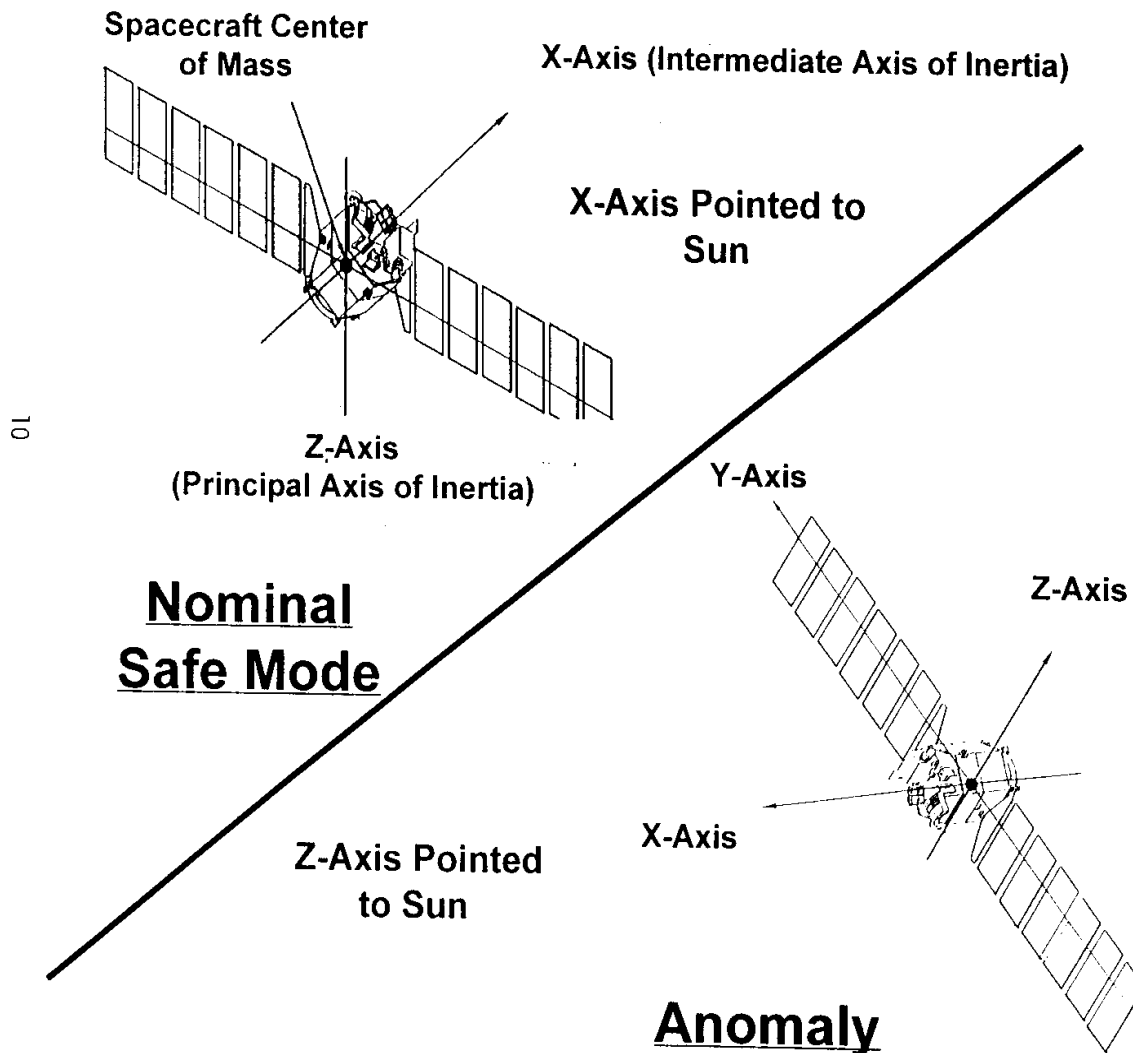
Lewis Flawed ACS Design

Flawed ACS Design. The Safe Mode was required by TRW specification to maintain the spacecraft in a safe, power positive orientation. This mode was to drive the solar panels to a predetermined clock position, to orient the spacecraft intermediate axis (the x-axis) toward the sun and to maintain that orientation autonomously using thruster firings without ground station intervention for a minimum of 72 hours in mission (523km altitude) orbit. This was implemented using a single two-axis gyro that was unable to sense rate about the spacecraft intermediate (x-axis). Therefore, when the spacecraft tried to maintain attitude control, a small imbalance, perhaps in thruster response, caused the spacecraft to spin up around the not-sensed x-axis. Because the spin was about an intermediate axis, the spin momentum started to transfer into the controlled principal axis (z-axis) causing the thrusters to fire excessively in an attempt to maintain control. The ACS processor was programmed to shut down the control system if excessive firings occurred. When both the A-side and the B-side thrusters had been shut down sequentially, the spin momentum that had been built-up in the intermediate (x) axis transferred into the principal (z) axis. This had the effect of rotating the spacecraft up to 90 degrees in inertial space causing the solar arrays to be pointed nearly edge-on to the sun. The spacecraft then drained its battery at a significantly fast rate because of the power subsystem and thermal subsystem Safe Mode design.

- Safe Mode points x-axis to sun; x-axis spin rate not sensed; thruster imbalance caused spin about x-axis, x is intermediate/unstable axis; thruster firings required to keep x-axis pointed to sun
- X-axis spin rate caused disturbance torques to build in other axes—resulted in excessive thruster firings; caused autonomous shut down of thrusters
- Momentum vector remains fixed; in absence of active control, s/c transfers spin from X to Z axis
- Points solar array nearly edge on to sun
