**SOHO Mission Interruption Joint NASA/ESA  
Investigation Board**

**Final Report**

**August 31, 1998**

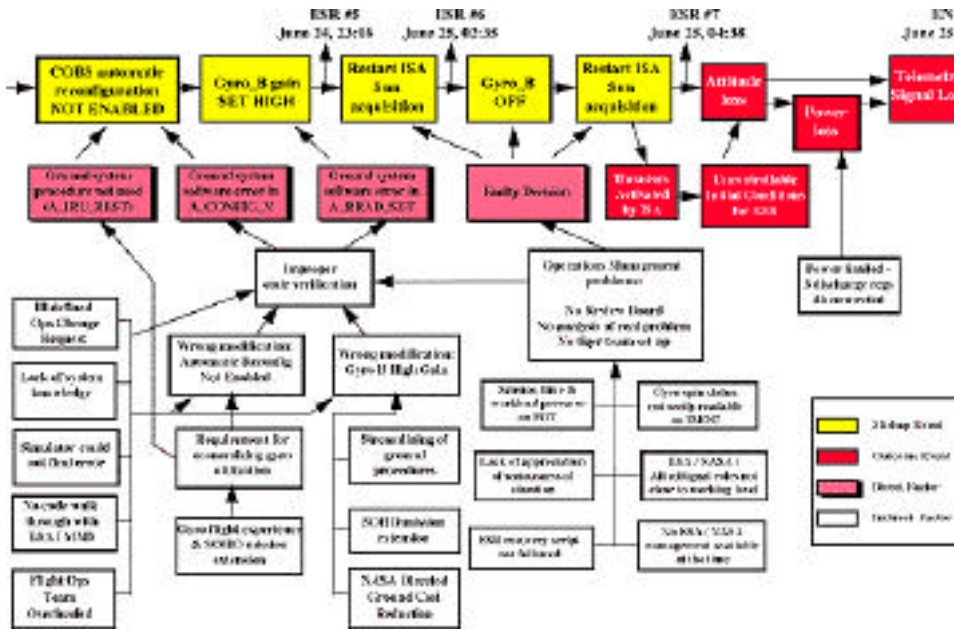
## Appendix D. SOHO Failure Event Tree

The first two errors were contained in predefined command sequences executed from the Ground System, while the last error was a decision to send a command to the spacecraft in response to unexpected telemetry. The sequence of these errors and their relationship to the triggered-ESRs are graphically depicted in Diagram 1.

Following the momentum management maneuver, Gyro B, which is used for fault detection, was erroneously left in its high gain setting, resulting in an indicated roll rate of 20 times greater than actual. **The incorrect gain was due to an error in another predefined command sequence; this error resulted in an on-board fault detection output that triggered an ESR.** This ESR, the 5th since launch, occurred at 7:16 PM EDT (23:16 UT), June 24, 1998.

After transitioning to the ISA mode as part of the normal ESR recovery sequence, the attitude control system began integrating the gyro drift rate bias associated with the still despun Gyro A. After 15 minutes, this resulted in roll thruster firings intended to null the apparent (but non-existent) roll attitude error. In less than one minute, the roll rate was sufficiently high to trigger the Gyro B based fault detection once again, resulting in ESR-6 at 10:35 PM EDT (02:35 UT), June 24, 1998.

During ESR-6 recovery, Ground Operations commanded the spacecraft to ISA mode. In ISA, the attitude control system resumed firing roll thrusters in an attempt to null the attitude error associated with the electrical rate bias term of the despun Gyro A. Gyro B and the associated fault detection were now inactive. The increasing roll rate eventually resulted in pitch and yaw Sun-pointing errors that exceeded a prescribed limit of five degrees, resulting in ESR-7 at 12:38 AM EDT (04:38 UT), June 25, 1998. Due to the gyroscopic cross-coupling torques caused by pitch and yaw thruster firings, and the absence of true roll rate indications, the ESR controller was no longer stable, and the spacecraft attitude diverged. **The incorrect diagnosis of a Gyro B fault and the subsequent ground response to this diagnosis ultimately resulted in loss of attitude control, subsequent loss of telemetry, and loss of power and thermal control.** Loss of telemetry occurred at 12:43:56 AM EDT (04:43:56 UT), June 25, 1998. It can not be determined whether this loss was a consequence of insufficient power or a loss of communication link caused by spacecraft attitude.
