Apollo Main 15 Parachute Failure

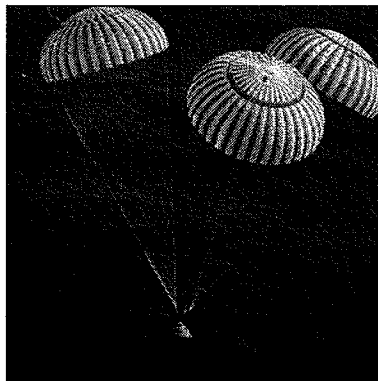
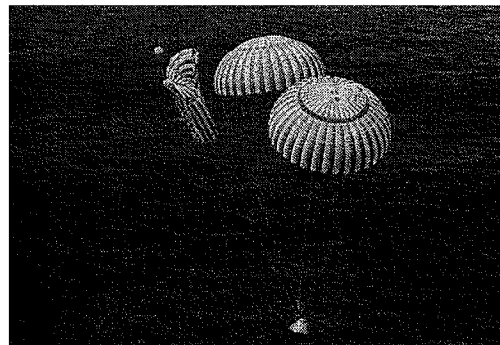
- Apollo Main Parachute System
 - Risers
 - Suspension Lines
 - Canopy

- Damage found on risers and suspension lines
 - Caused canopy to fail
- Normal dumping of fuel during descent
 - Caused being exceeding temperature limits for risers and suspension lines

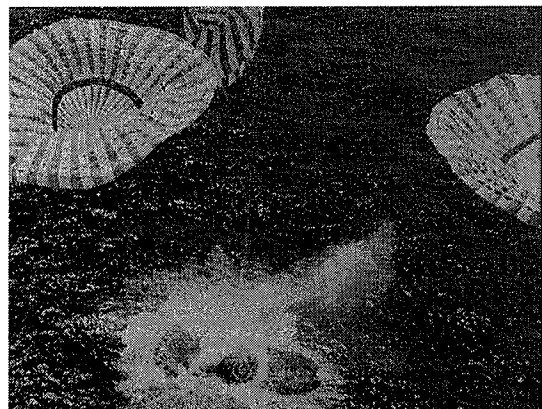
- Loss of 1 entire effective canopy
- Only 2 were required for safe operation
- Increased velocity on splashdown
- Less comfortable
- **Severity: 7**

- Anomaly report found likely cause to be RCS fuel expulsion during descent
 - RCS system is used to stabilize entry, but not entire fuel reserve is utilized
 - Excess fuel is dumped before splashdown

- **RPN Score: 560** Need to decrease Severity, then Occurrence, then Detection scores
- Increase amount of oxidizer in propellant
- Increase time delay before RCS thrusters turn off and fuel dumps
- Create orientation sensor to avoid dumping during parachute alignment with RCS thrusters
- Add thermal sensors on risers to take action if temperatures increase beyond limits prior to failure

- Responsible Person:
Failure Investigation Committee Chair: **John Christian**
 - Complete by: February 1972
1. Increase time delay from 42 to 61 seconds
 2. Increase ratio of oxidizer to fuel
 3. Conduct Additional Tests
 4. Add thermocouples to risers
