The Hubble Space Telescope Optical Systems Failure Report

November 1990

National Aeronautics and
Space Administration

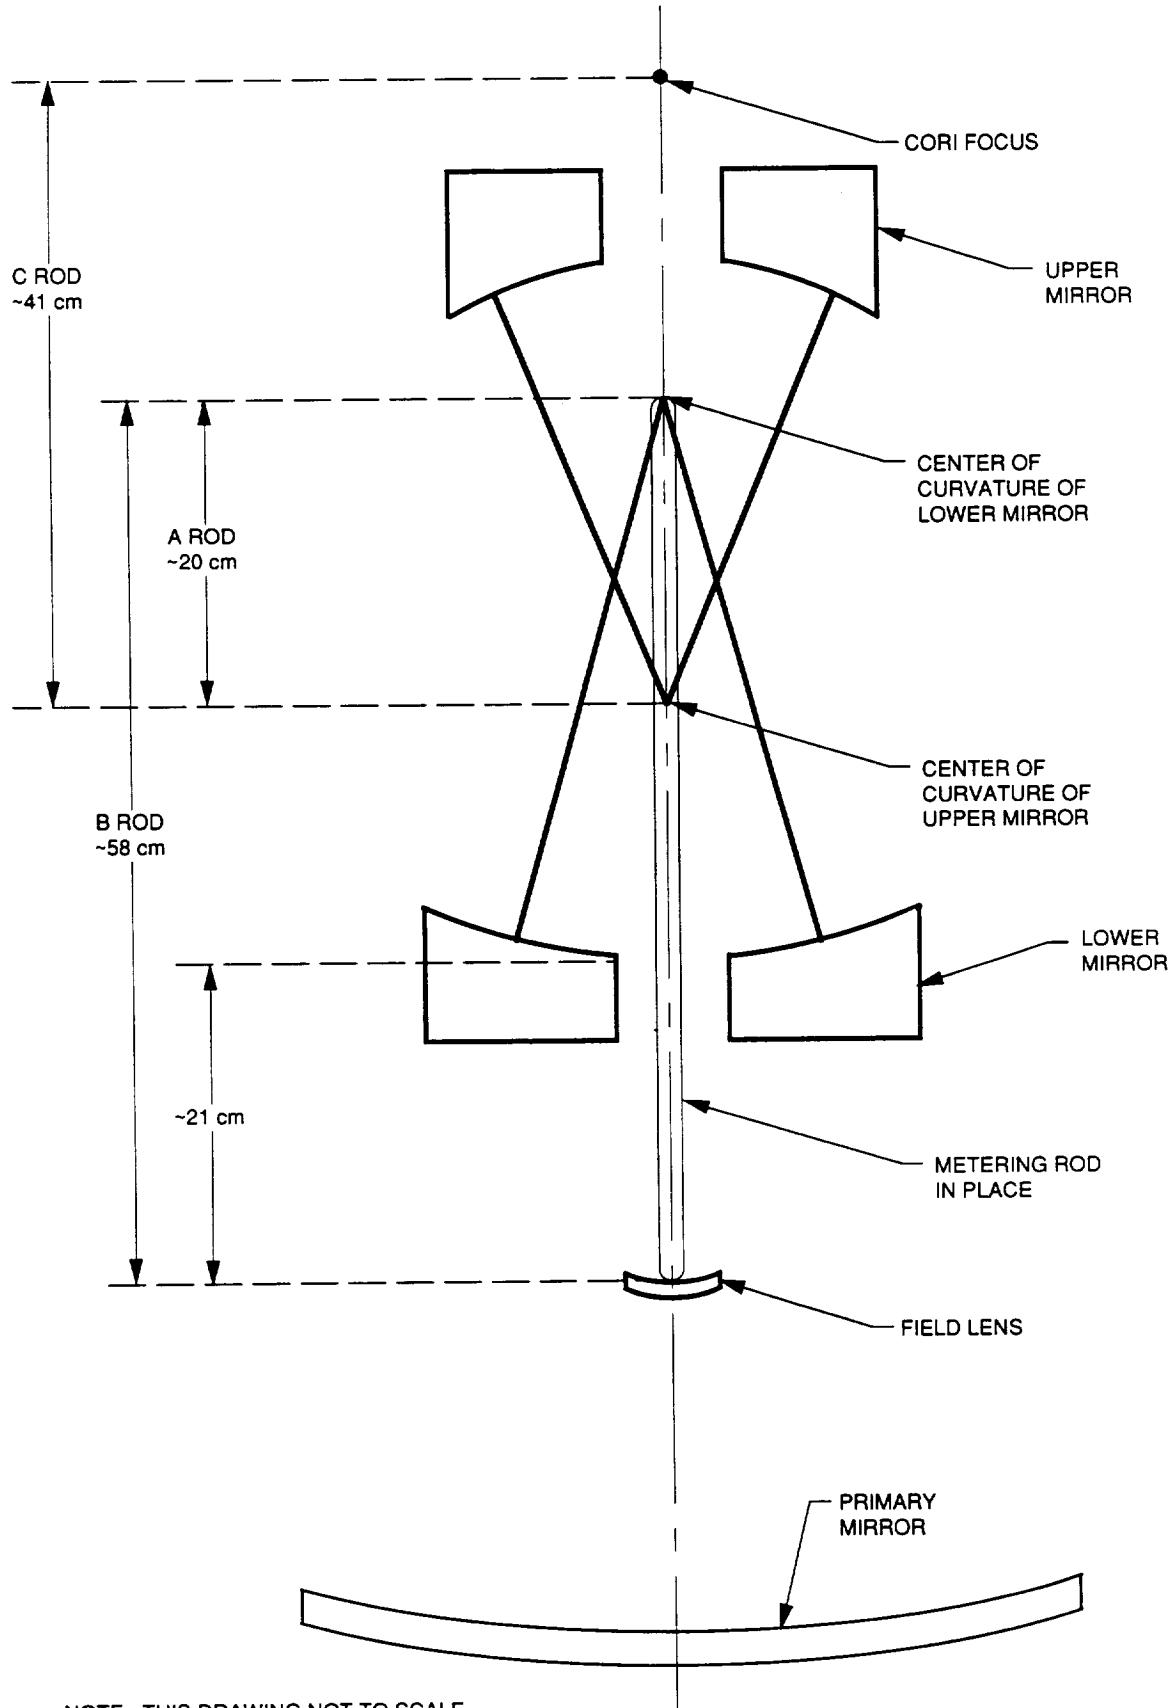
Figure 7-1. Position of metering rods used to space optical elements in the reflective null corrector.

At the beginning of the program to build the 2.4-m Hubble primary mirror, P-E modified the RNC that had been used in building a 1.5-m mirror prototype. This modification required adding a new field lens and respacing the optical elements to create the correct shape for the larger mirror. Figure 7-1 is a schematic of this RNC, including the positions of the metering rods used to set the optics.

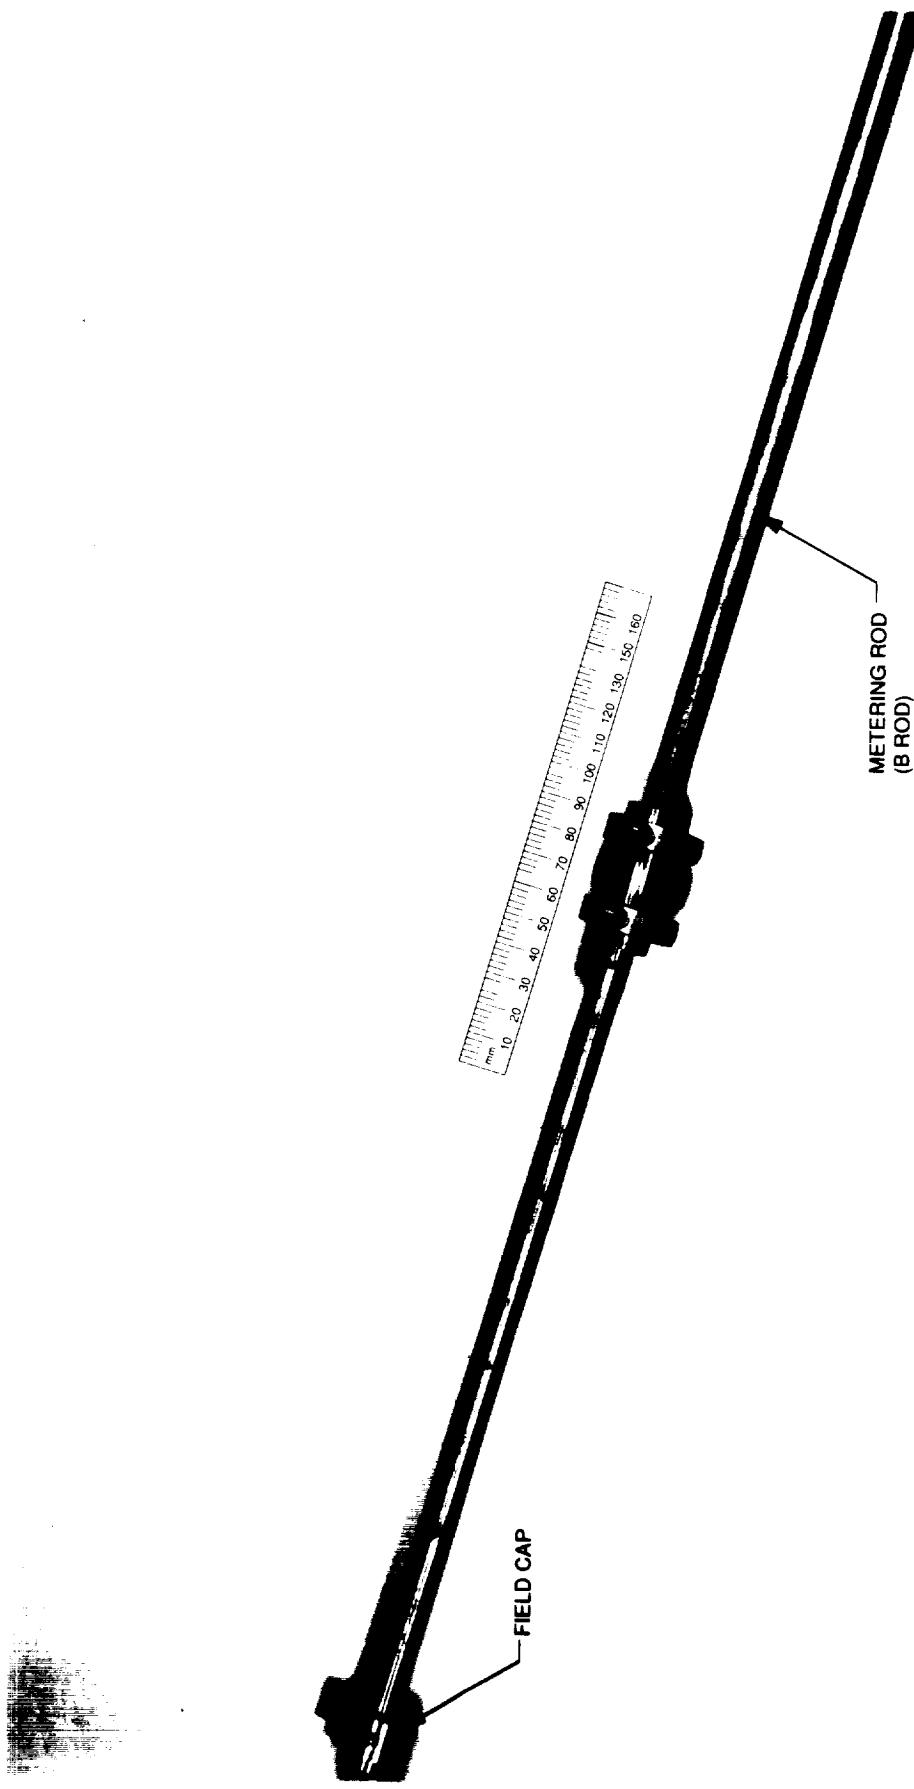
Figure 7-2. Metering rod (B rod) used to space the field lens and the center of curvature of the lower mirror in the reflective null corrector.

There were three metering rods (labeled A, B, and C) made of Invar, a metal with a small temperature expansion coefficient. The ends of the metering rods were rounded and polished because the very precise positioning of the optics in the RNC used an interferometer, rather than a mechanical measurement. This procedure involved auto-reflecting a focused beam of light off the end of a rod and observing an interference pattern from the beam that came back on itself. Centering the light beam on the rod end was essential for the measurement. To prevent the metering rod from being misaligned laterally with respect to the interferometer axis, P-E decided to attach "field caps" to one end of the rod (Figures 7-2 and 7-3). The field caps were fitted over the rod ends and had a small aperture in the center to ensure centering of the rod on the beam.

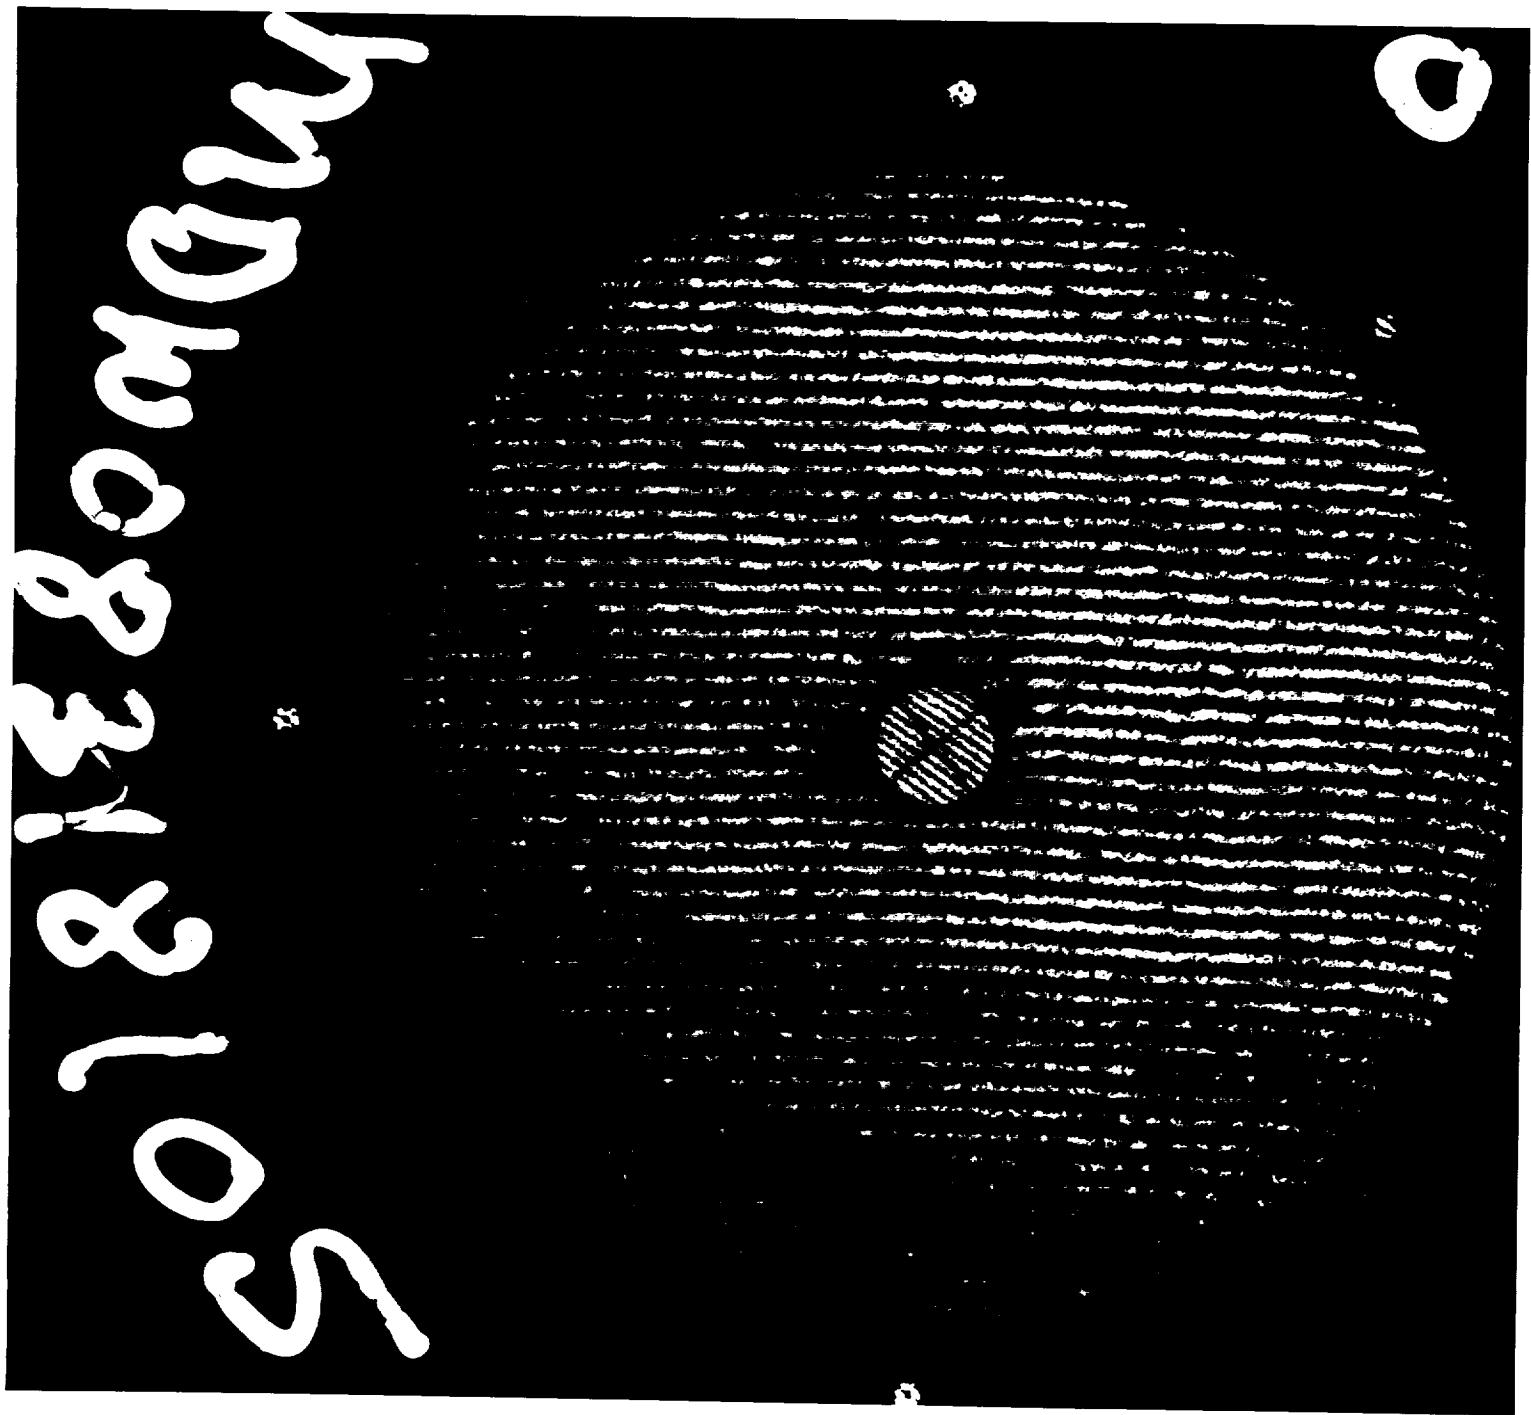
**Figure D-4. Hindle Shell interferogram of the secondary mirror, taken
August 31, 1981.**

Analysis of this interferogram in 1990 supports, with only minor differences, the predicted quality of the surface shape.
