**NOAA N-PRIME Mishap Investigation**  
**Final Report**

**September 13, 2004**

Report Title: NOAA N-Prime Mishap Investigation Report

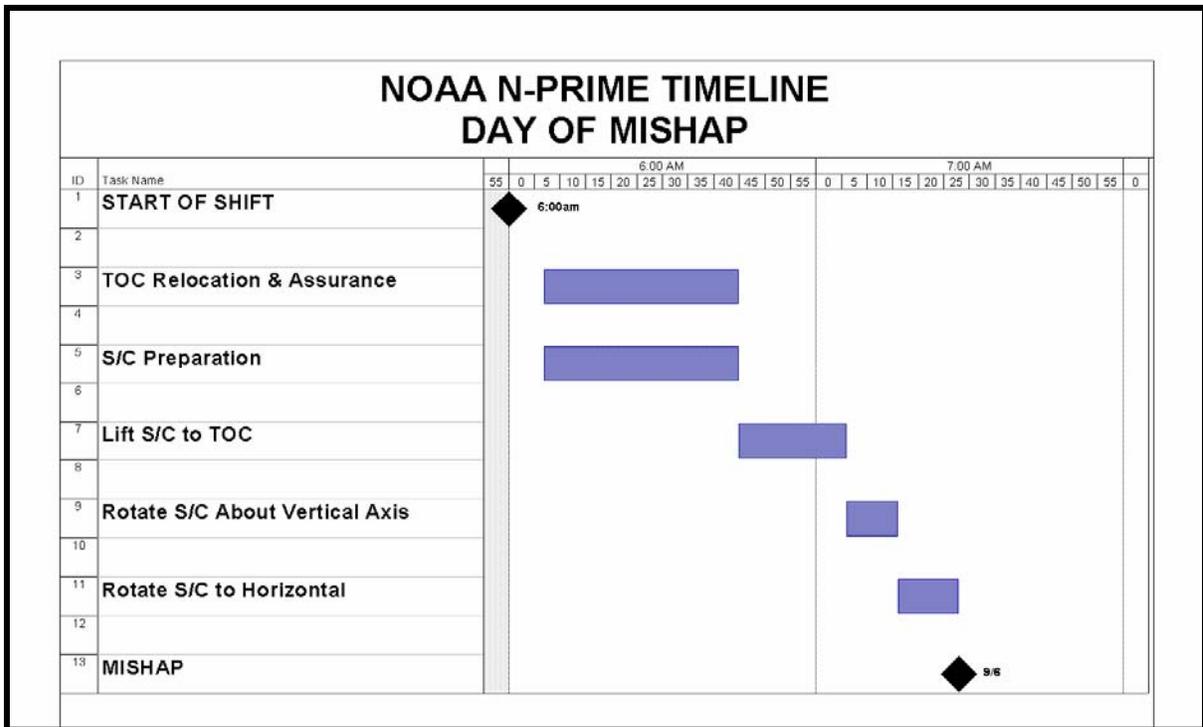
Figure 5-3: Timeline (Simplified)– Saturday Operation

A summary of the actual timing of the events is shown below in Figure 5-3: Timeline (Simplified)– Saturday Operation, and Table 5-1: Operation Event Timeline, and with greater detail in Section 5-5.

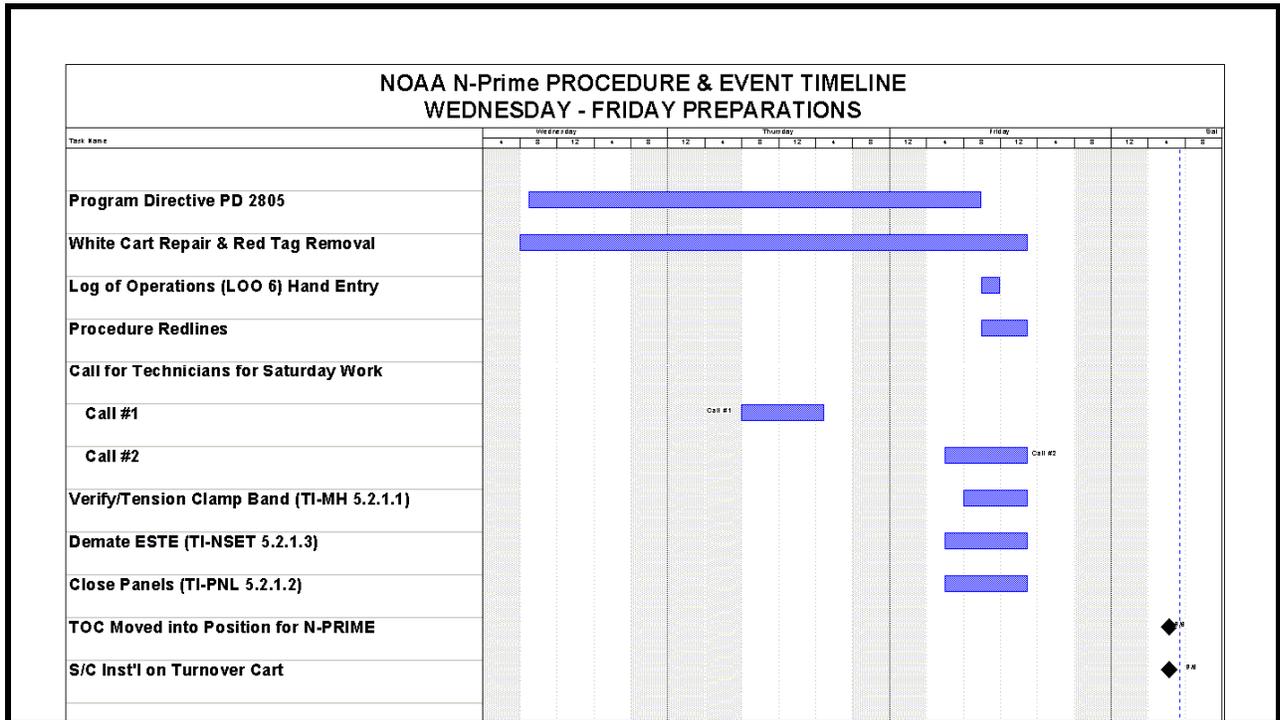
Figure 5-4: Timeline for Wednesday – Friday Preparations

The operation was planned during the period from Wednesday, 3 September 2003, through Friday, 5 September 2003. (Figure 5-4: Timeline for Wednesday -Friday Preparations)

On Wednesday, September 3, the NOAA N-PRIME MHS Shimming activity schedule was moved ahead from the initial plan to begin on September 10 to the updated plan to begin on September 6, the date of the mishap. Some of the preparation work on the flight spacecraft, such as tensioning the V-band, actually began on Friday, September 5. This short-notice advance in the schedule date had several consequences. The TOC required repair to remove a red tag, leading to a repair that was acceptable but required a subtle change in how the spacecraft was mated to the TOC. In addition, technicians were requested to perform operations on the flight spacecraft without released paperwork, leading to dissention among some of the NOAA I&T Team, and resulting in at least one key team member not working on Saturday. The accelerated pace may have led to less communication between the two programs sharing the TOC. Each of these factors is discussed in more detail in later sections.

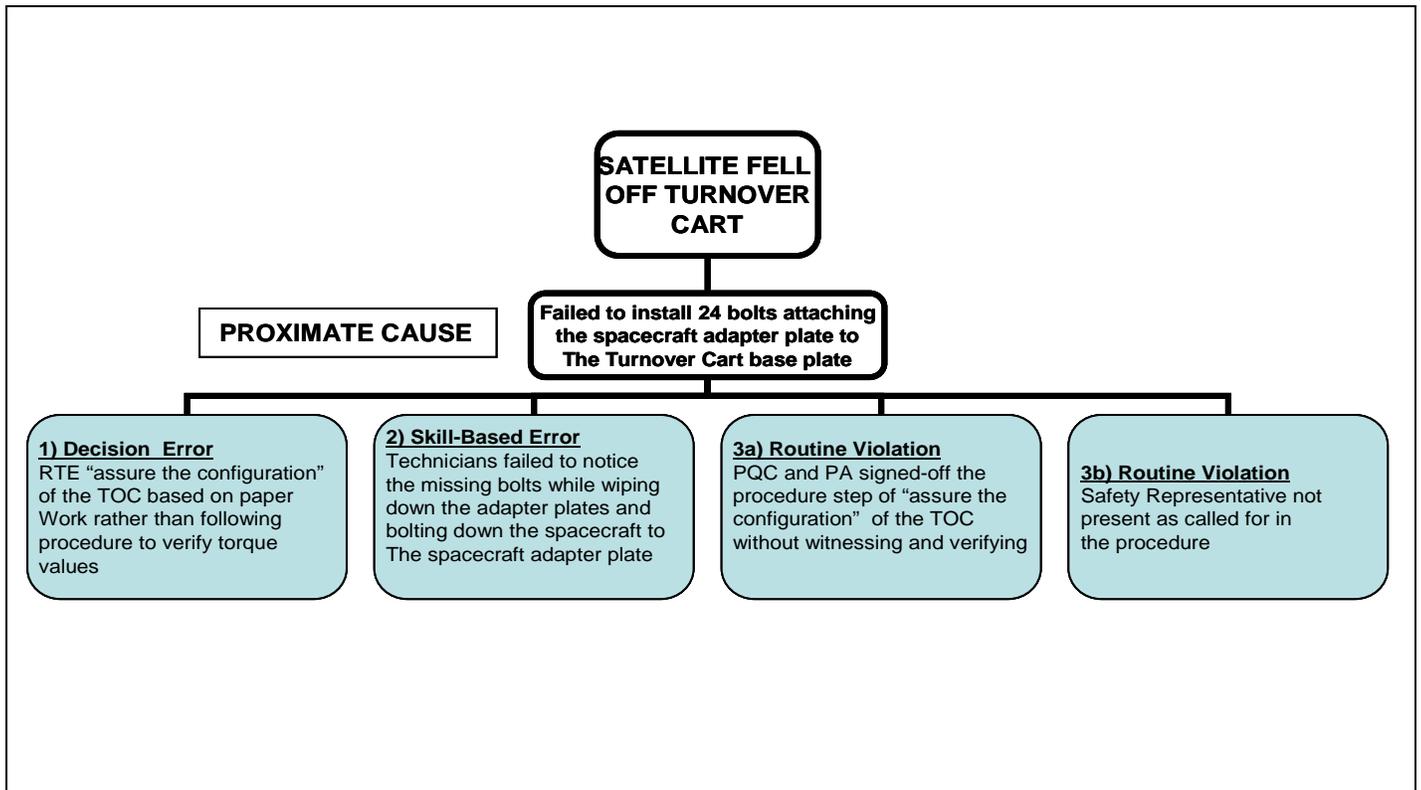
**Figure 7-1: Level 1 Active Failures or Unsafe Acts Leading to the NOAA N-Prime Mishap**

*The proximate cause of The NOAA N-PRIME mishap was the failure of the LMSSC operations team to follow procedures to properly configure the TOC, such that the 24 bolts that were needed to secure the TOC adapter plate to the TOC were not installed.*

The MIB identified root causes along the four levels of active or latent failures as ascribed by the HFACS framework. The supporting findings for these root causes are presented in this section. Figure 7-1 illustrates the Level 1 active failures or unsafe acts leading to the mishap and Figures 7-2, 7-3, 7-4, & 7-5 trace each of the active failures to the three levels of latent failures as ascribed by the HFACS framework. The findings of this analysis are numbered sequentially and are described in more detail in the text that follows.
