COMET NUCLEUS TOUR CONTOUR

MISHAP INVESTIGATION BOARD REPORT MAY 31, 2003

National Aeronautics and Space Administration

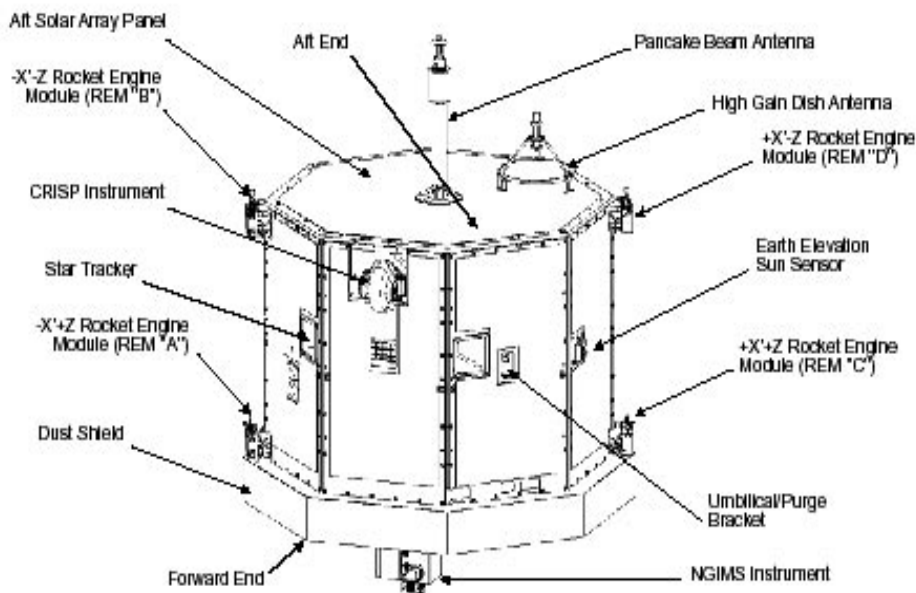
Figure 1.
The CONTOUR spacecraft.

The spacecraft body (Fig. 1) was an aluminum octagon with solar cells mounted on the sides and back. The spacecraft had multilayer dust protection to survive the expected impact environments at the comet targets. The dust shield, built of multiple layers of Nextel® with a Kevlar® backstop, protected the forward end of the spacecraft, except where the solid rocket motor (SRM) nozzle protruded through the dust shield.

The CONTOUR Board concludes that the probable proximate cause for loss of the CONTOUR spacecraft was overheating of the forward-end of the spacecraft due to base heating from the SRM exhaust plume. The CONTOUR SRM nozzle was embedded within the spacecraft to a greater degree than is typical (Fig. 3), and the resultant near-field effect of exhaust plume heating was not adequately accounted for in the design. Overheating may have caused substantial material weakening and structural degradation, which could have led to catastrophic dynamic instability. The deficiencies in the design process are discussed further in sections 5 and 6 of this report.
