**LEWIS SPACECRAFT MISSION FAILURE
INVESTIGATION BOARD**

FINAL REPORT

12 February 1998

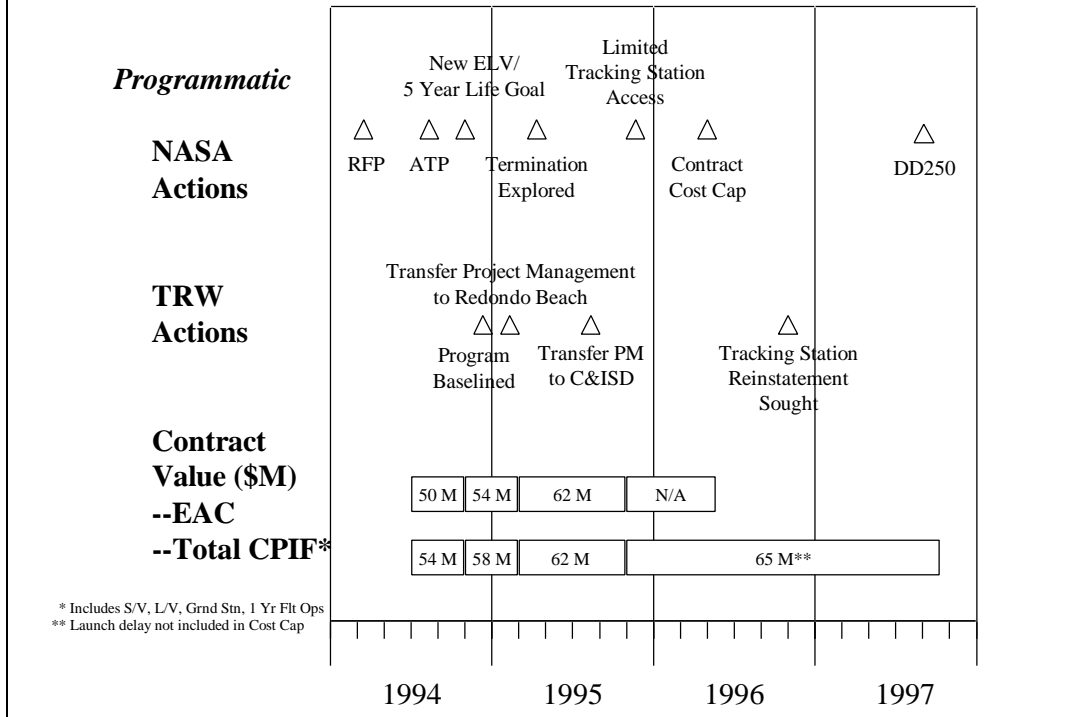
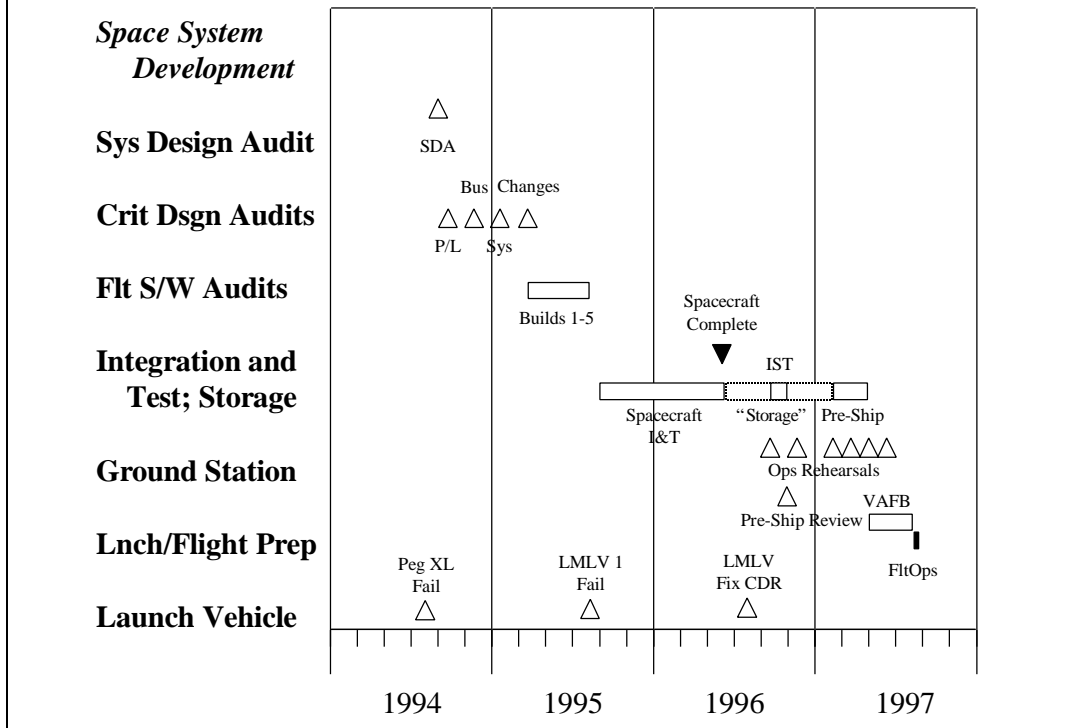
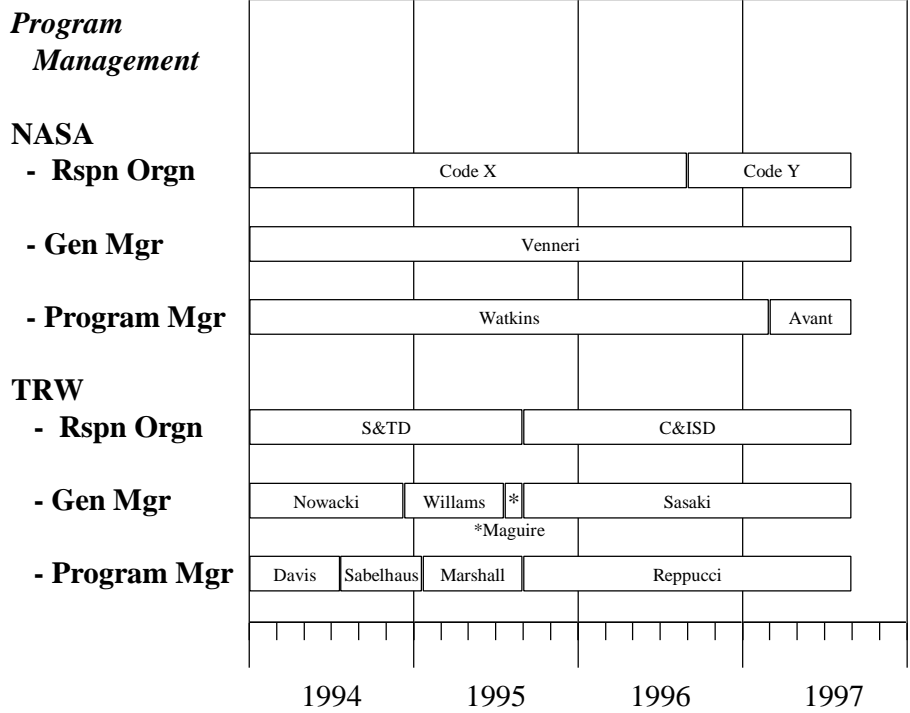
SSTI Lewis Program Timeline

The Lewis Program experienced a large turnover in key TRW personnel. There were four Division Managers and four Program Managers in a 14-month period. Each Division Manager had a different management philosophy with regard to achieving success. The most significant change occurred in August 1995 when Lewis was moved from the Space & Technology Division (S&TD) to the Civil & International Systems Division (C&ISD). Not only did the program management change but also numerous other personnel changes occurred including the loss of the Systems Engineer, and the Integration and Test lead engineer. A NASA perception was that a major change in philosophy also occurred at this time due largely to the move to the C&IS Division. It was believed that this shift signaled a move from “innovative processes” to “business as usual”. Informal integrated product development team meetings were stopped and focus on controlling cost became paramount. Program management relations between NASA and TRW deteriorated to an adversarial state. There are no indications that NASA management took corrective action based on this perception to assure that their Faster, Better Cheaper objective would continue to be a part of the program. This lack of action is of concern to the Board because it raises the question of how the Government viewed its role in the Faster, Better, Cheaper implementation of the program.
